"Full" Reserve Study

Whitley Bay Condominiums Cocoa, FL

Report #: 36044-0
For Period Beginning: January 1, 2020
Expires: December 31, 2020

Date Prepared: May 6, 2019

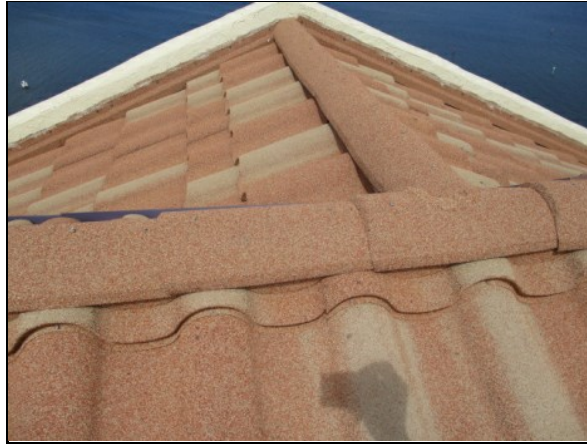
Comp #: 2384 Roofing (Metal) - Replace

Useful Life:
30 years

Remaining Life:
27 years
