**Whitley Bay Condominium Assoc.
93 Delannoy Ave,
Cocoa, FL 32922**

***Condition Survey Report Of: Balconies, Walkways and
Garages***

**RE: Whitley Bay Condominium – Concrete Restoration and Painting
Cocoa, Florida
KEG File No.20RD-0207**

REPORT OF LIMITED CONDITION SURVEY AND RECOMMENDATIONS

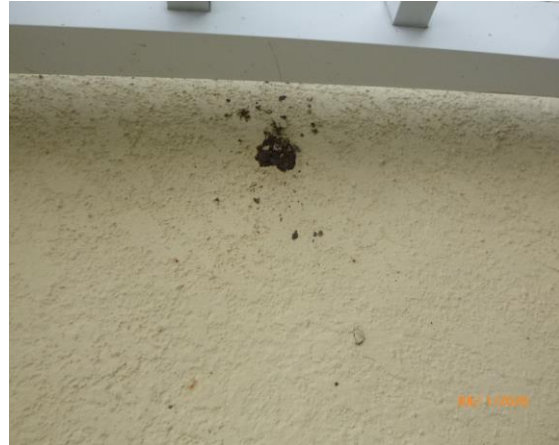
Photo #2: Rust spot at unit 701

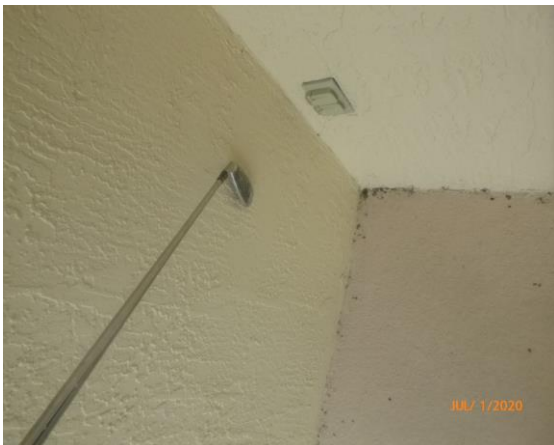
Photo #3: DLS on the wall at unit 1105

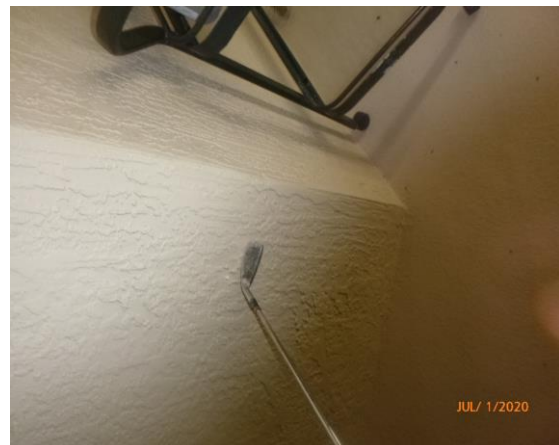
Photo #4: DLS on the wall at unit 1006

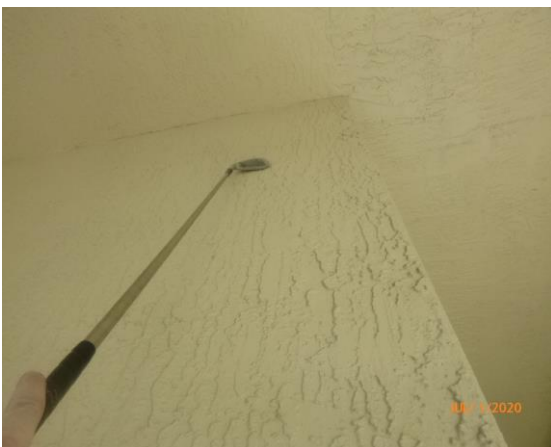
Photo #5: DLS on th wall at unit 1201

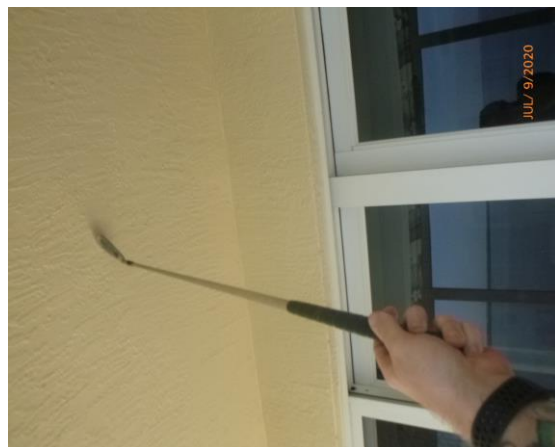
Photo #6: DLS on ceiling at unit 805

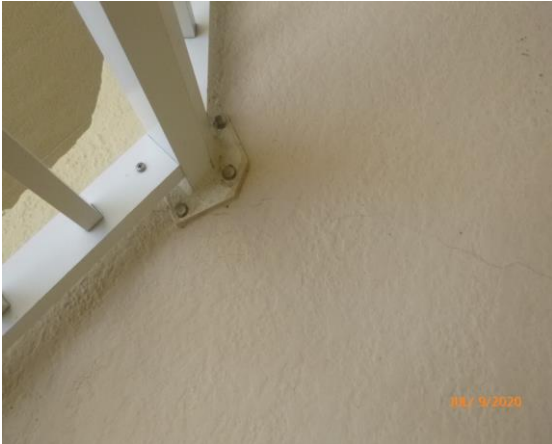
Photo #7: Crack on floor on PH walkway

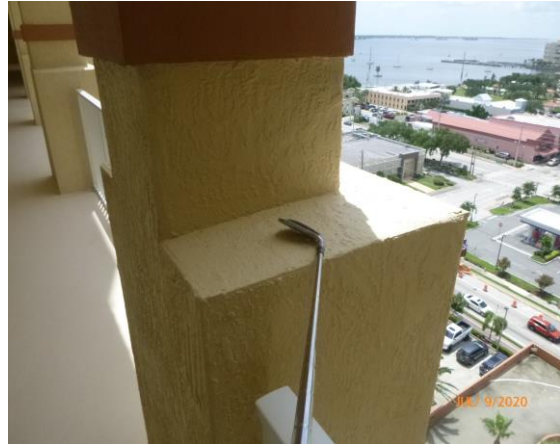
Photo #8: DLS on column on 12th floor walkway

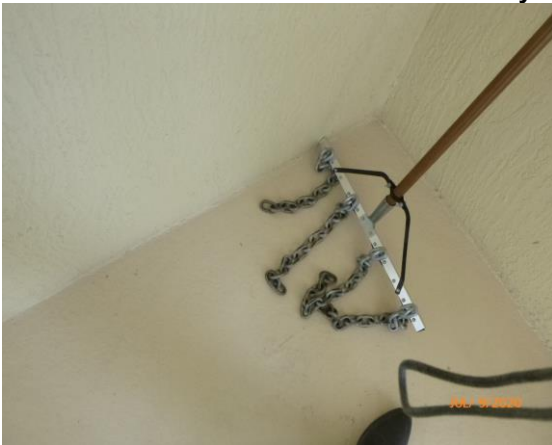
Photo #9: Spall on 12th floor walkway

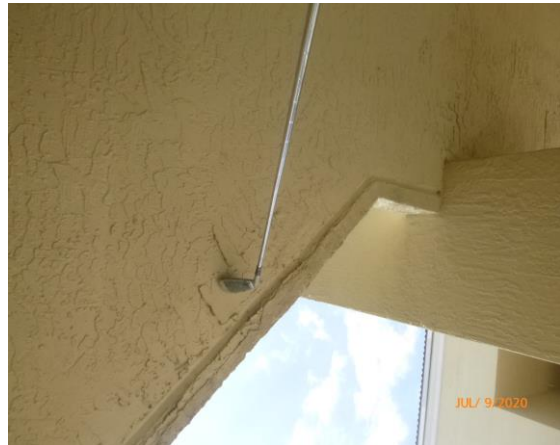
Photo #10: DLS on ceiling on 11th floor walkway

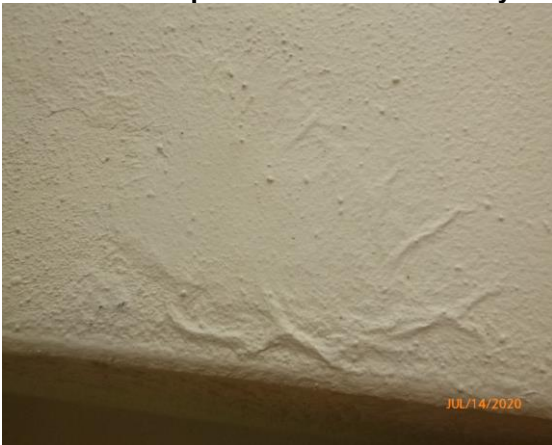
From our inspection performed on the paint system on the walls, columns, and ceilings, we could identify some areas of peeling paint, blisters, deteriorated paint, and missing paint. Peeling paint or blistering of the paint is a failure of coating not properly adhering to the subsurface. Moisture, high alkalinity, surface contamination, and paint applied over multiple layers of paint are some of the common reasons for paint failure. KEG observed an estimate of 9 square feet of paint issues on the walkways.

Photo #11: Paint blister on 6th floor walkway

Paint is the first layer of protection of the building. It was informed that the building will go through its painting cycle in one or two years. Based on this information the areas that are bubbling, or detaching should be repair, to avoid water intrusion. Once on the painting cycle, a pressure wash and new paint should be applied to extend the life of the building.

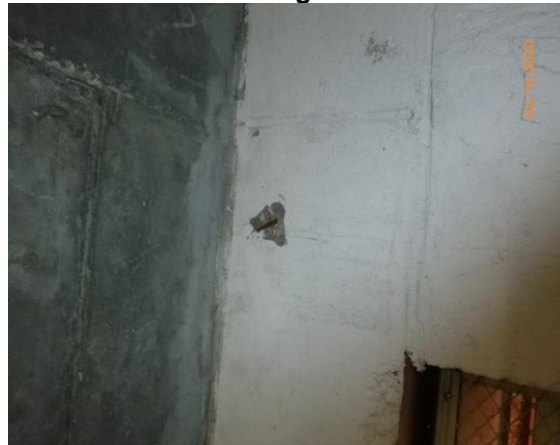
Photo #12: Spall with exposed metal

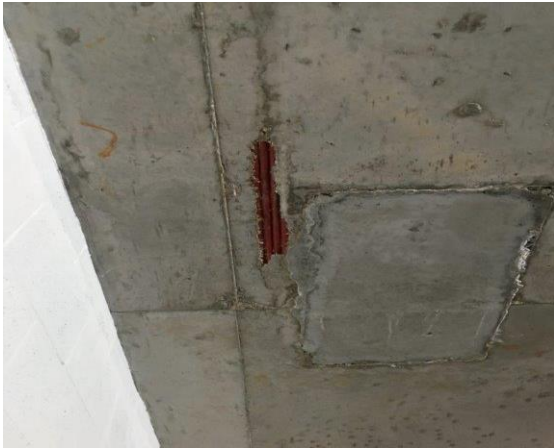
From our survey of the garages, that includes the west wall, we were able to observe cracking, rust spots/ exposed metal, and spalling. We were able to observe a minimum of 590 feet of cracking, a minimum of 6 exposed metals, and were able to observe a minimum of 11 cubic feet of concrete spalling. Also, we observed two areas that were showing the post tension cables housing.

Photo #13: Exposed Post Tension Cable Housing

Besides the concrete repairs, the Parking Garage has two additional elements that should be addressed, the exposed post tension cable housing and the water intrusion at the west wall adjacent to the planter box. To address the post tension cables, a more detail analysis must be made to determine the location, tension and other components of the post tension cables to provide a proper solution. The post tension plans used during construction, if available, should be provided to KEG to properly evaluate the condition and determine solutions to remediate the exposed housing.

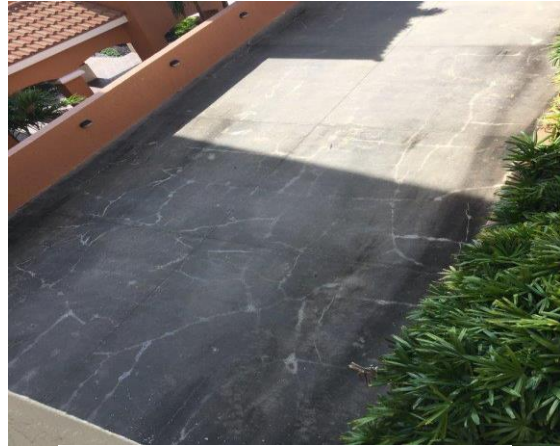
From our observations of the parking garage ramp, we were able to notice cracking of the driving surface, spalling on the perimeter walls, and joint sealant failure at the lower sections of the walls where it meets the parking garage ramp. Some of the cracking pattern are consistent with expansion and contraction of the concrete slab. All cracks should be repaired to minimize the water intrusion to the structural elements.

Photo #14: Ramp at Parking Garage

The damage at the parking deck ramp should be address as a concrete repair including crack repair procedures. The joints between the walls and remap should be replaced and as well as the expansion joints.

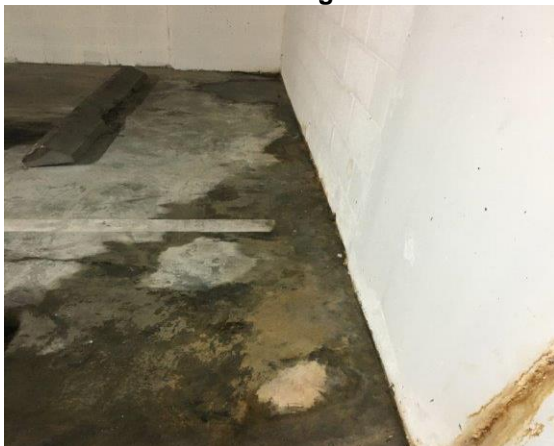
The west wall of the parking garage is part of the planter box next to the ramp. The west wall is showing water intrusion which indicates that the planter is holding water and the west wall is not properly waterproof or the waterproofing system has exceeded its useful life. The west wall is partially reinforced and allowing water to gain access to the interior of the wall could cause additional deterioration.

Photo #15: West Wall Water Intrusion

The water intrusion at the west wall adjacent to the planter box could have various methods of repair. The critical part to determine a proper solution is to determine the location of the water intrusion. Since this is a CMU wall, the water could be penetrating from areas higher than the bottom section, that is showing the water leaks. The most effective way to waterproof the wall is by removing all the dirt next to the wall and apply a waterproof system. However, this method is expensive, and most Associations avoid this method. A more economical solution could be the use of injection materials along the wall to create a seal.
