THE ASSOCIATION OF PELICAN POINT, INC. STRUCTURAL INTEGRITY RESERVE STUDY

For 30-Year Projection Period: FY 2023 through FY 2053

Reference #: 1120.23

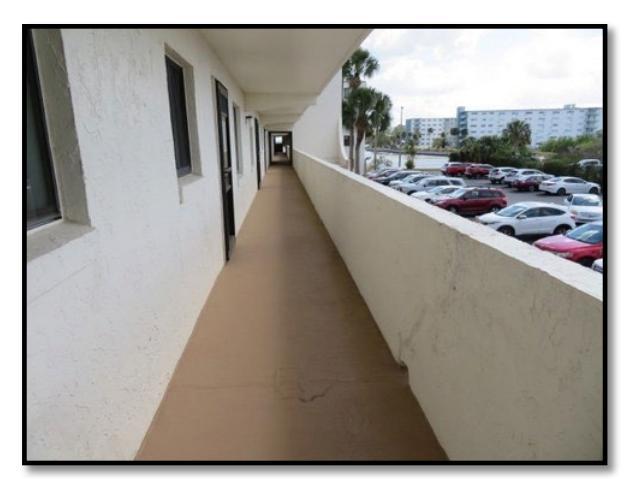
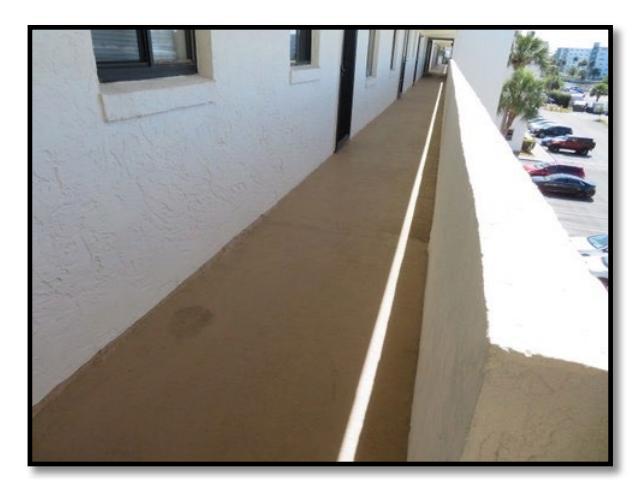
Figure 1

Pelican Point maintains breezeways and exposed balconies that comprise approximately 11,835 square feet of concrete surface. The balcony and breezeway coatings are in fair overall condition. Balconies and breezeways have a long useful life with the benefit of periodic maintenance. Concrete cracks and spalling occurs from the expansion of the reinforcing steel bars due to corrosion. Concrete corrosion is caused by rainwater and chlorides penetrating the surface of the concrete and contacting the embedded steel reinforcement bars. Failure to maintain the

Concrete cracks and spalling occur from the expansion of the reinforcing steel bars due to corrosion. Concrete corrosion is caused by rainwater and chlorides getting into the concrete down to the level of the steel bars. The Association should budget for partial repairs as needed by the milestone report provided by Beachside Engineering in 2024 prior to waterproof coating applications.

balconies and breezeways can lead to costly repairs. The Association should budget for waterproof coating applications and partial repairs as needed in 2024 and every 5- to 10-years thereafter in conjunction with paint finish applications. In addition, Pelican Point should budget for full coating replacement every 15- to 20-years beginning by 2032.

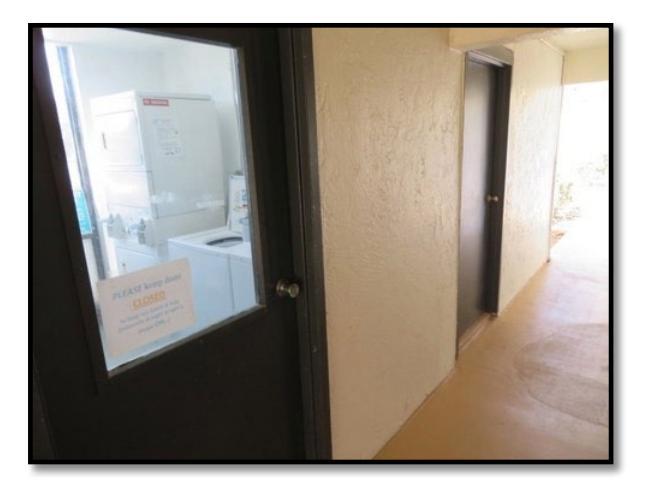
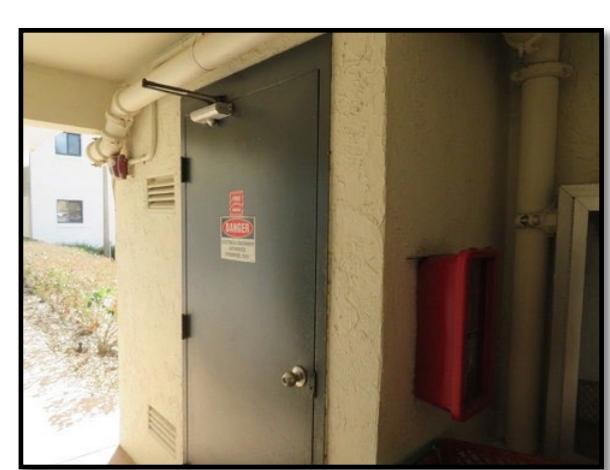
Figure 1

Pelican Point maintains approximately 30 common metal doors. The common doors are in fair overall condition at various ages. Doors have a useful life of up to 30 years. Based on the varied ages, the Association should budget for phased replacements of up to 10 doors every five years beginning in 2028. The estimate of cost is based on a fire rated self-closing door.

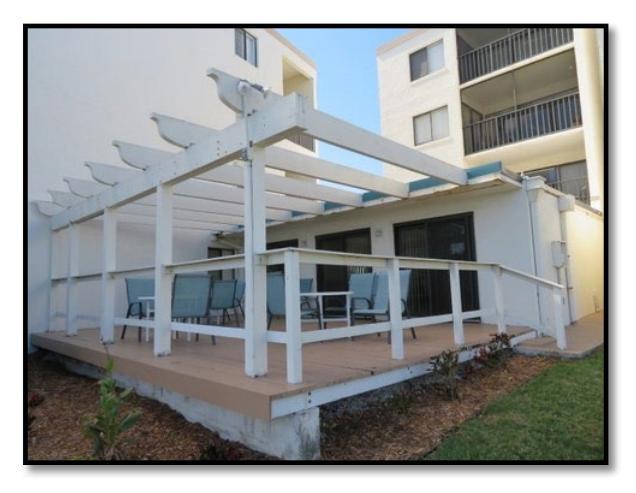
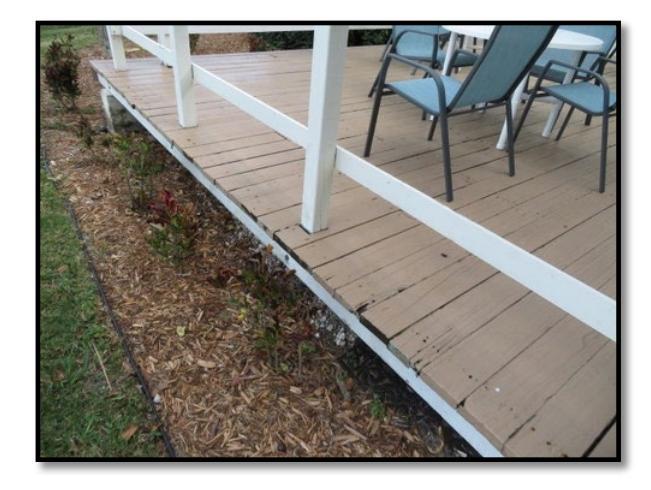
Figure 1 – Arbor and Deck Overview

The Association maintains approximately 480 square feet of wood decking and an arbor. The decking and arbor are in fair to poor condition. The useful life of these components is up to 25 years. Pelican Point should budget for replacement of the deck and arbor in 2024 and again by 2049. Interim repairs and partial replacements should be funded through the operating budget as needed.

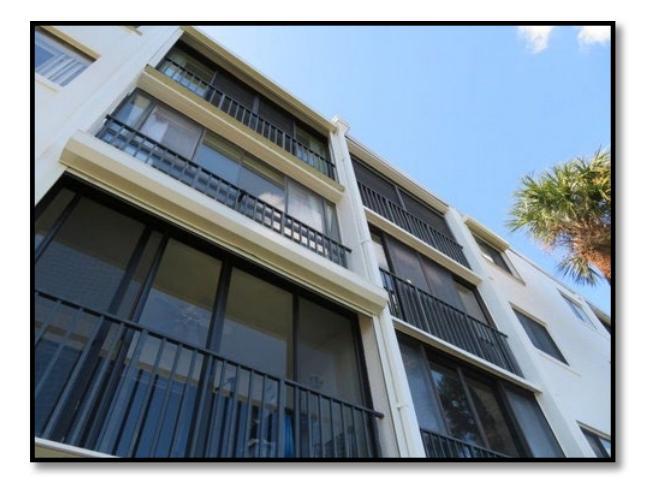
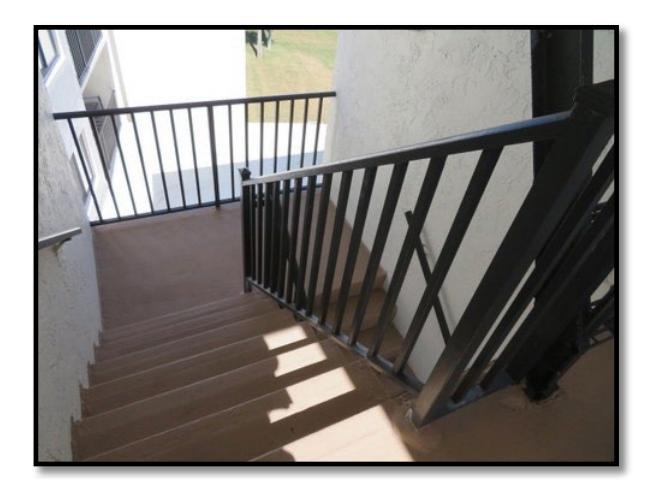
Figure 2 – Stair Railings

The balcony and stair railings comprise 1,190 and 420 linear feet respectively. These aluminum railings are original and in fair overall condition. The major concern with railings is safety. Aluminum railings have a useful life of up to 35 years. Pelican Point should budget for replacement of the railings in 2024 in conjunction with concrete repairs and waterproof coatings.

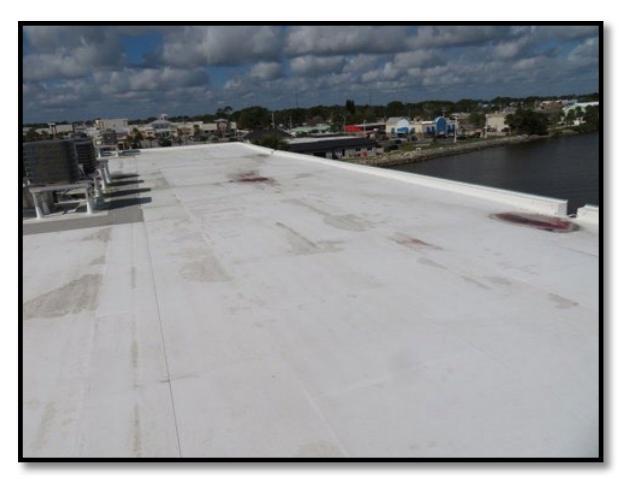
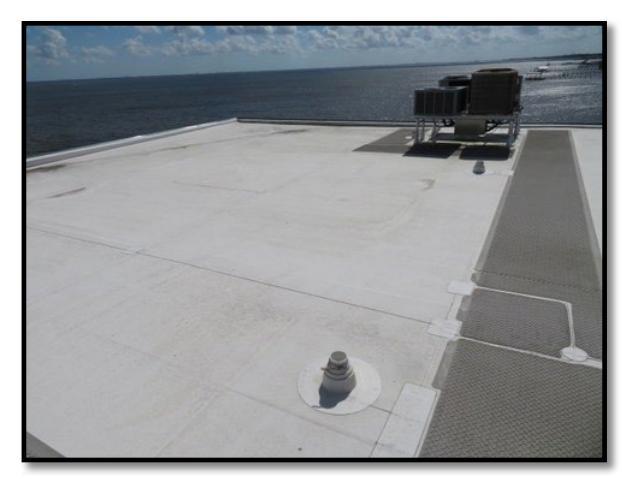
Figure 2 - Building C Roof

The Association maintains a total of 366 squares of flat roofs. The flat roofs are in good overall condition at an age of up to six years. Flat roof coverings have a useful life from 15- to 20-years.

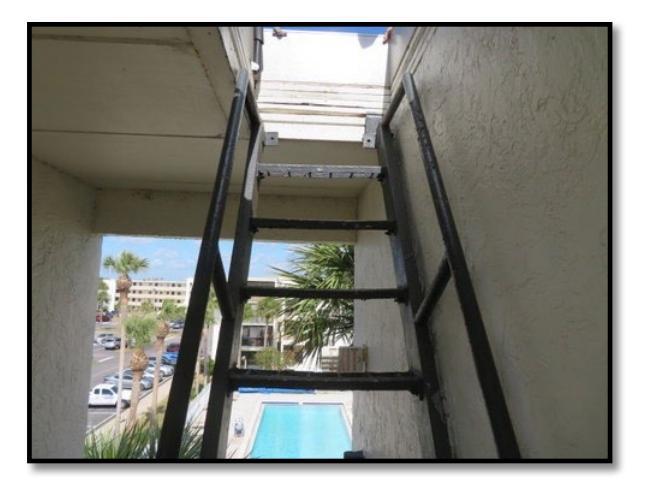
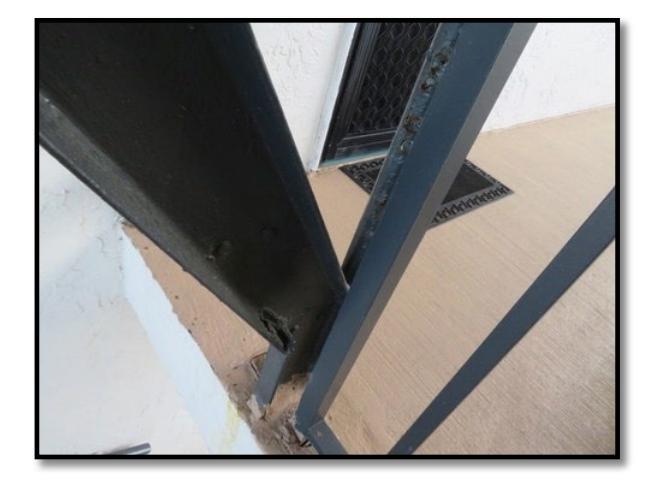
Figure 1

Three sets of staircases located at the fourth floor of each building provide roof access. The staircases are original and in fair to poor condition. The major concern with staircases is safety. Corrosion at the bases is noted. Steel structures of this type have a long useful life with the benefit of periodic maintenance. The Association budget for capital repairs and paint finishes periodically to maximize the useful life of the staircases. Capital repairs include removal of any built-up paint finishes and accumulated rust, repairs to the steel as needed, including welding, proper priming prior

to a new paint finish application and replacement of any damaged or deteriorated stair treads. Pelican Point should budget for replacements in 2024.

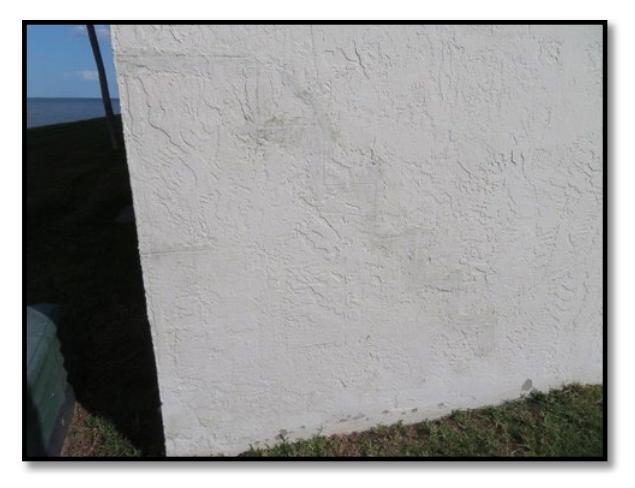
Management reports that the Association painted the sides and ocean sides of Buildings B and C in 2023. The remaining paint finishes are in fair to poor condition at an age of eight years. Paint finishes have a useful life from 5- to 10-years. Pelican Point should budget for the remaining paint finishes in 2024 following stucco repairs. Subsequent cycles are likely every eight years thereafter. The Association should plan for weatherizing the window sealants and any exterior penetrations as needed in conjunction with paint finish applications. The Association should also plan to have a licensed engineer that specializes in restoration projects to inspect and develop a plan for any repairs prior to paint finish applications.

Figure 1 - Step Crack Repair

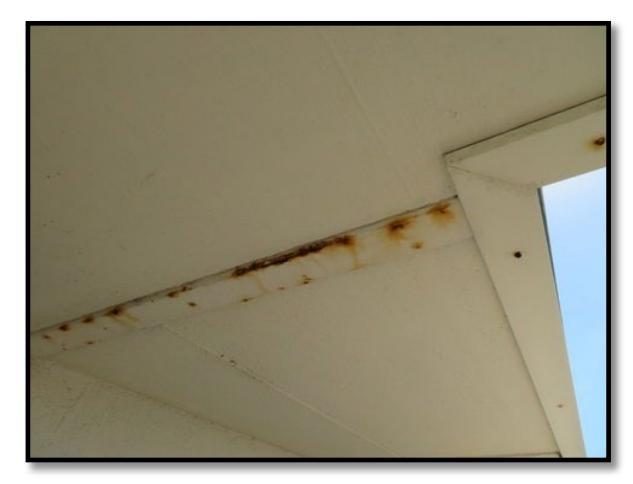
Figure 2 - Rust Caused by Water Intrusion

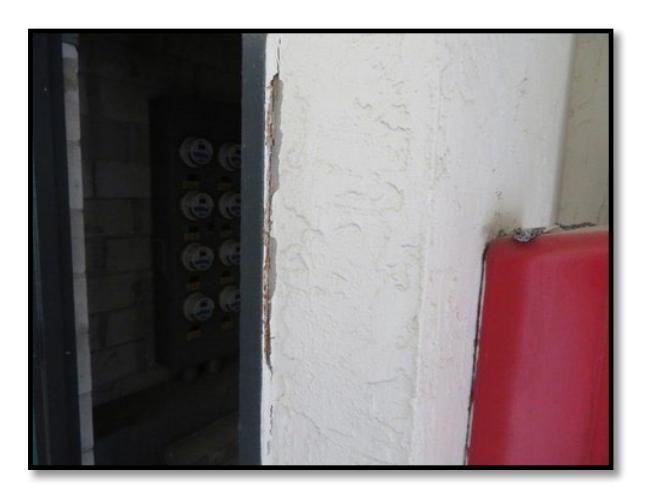
Figure 3 – Stucco Edge Crack

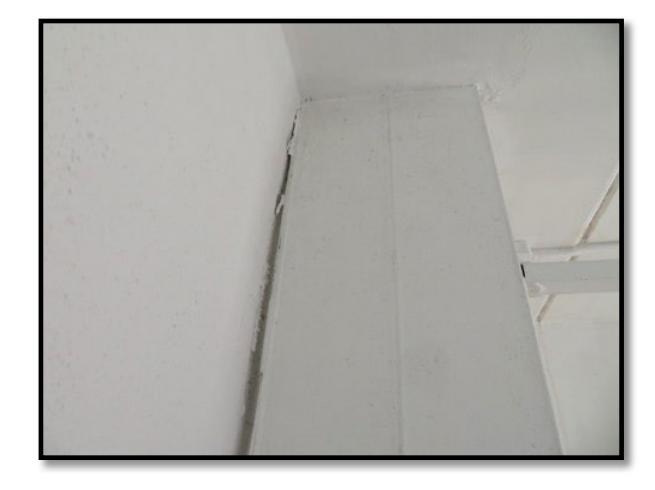
Figure 4 - Pool Rest Room Wall Settlement

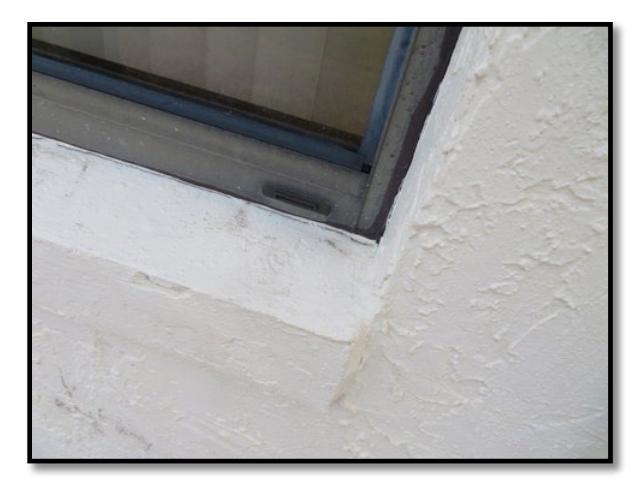
Figure 1 - Deteriorated Window Sealant

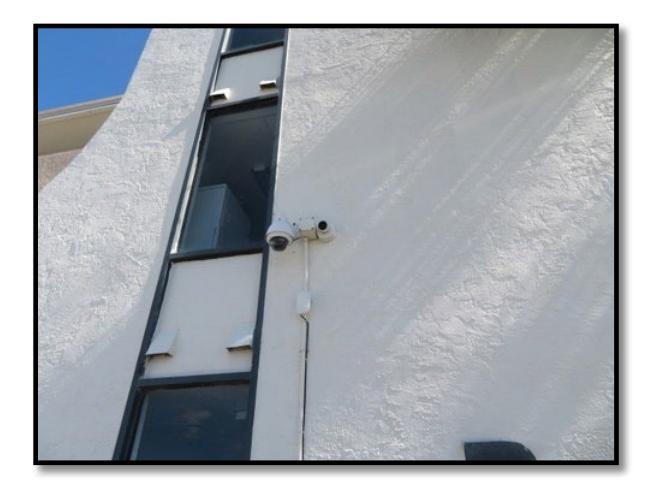
Figure 1 - Laundry Room Windows

The common windows and glass doors comprise 430 square feet. The windows and glass doors are original and in fair overall condition. Windows and glass doors of this type have a useful life of up to 40 years. The need to replace windows can be due to various reasons such as consistency in style and condition. There may be a cost savings with coordinated replacements. Pelican Point should budget for replacement of the windows and glass doors by 2025. The windows should meet the Florida Building Code for impact resistance.

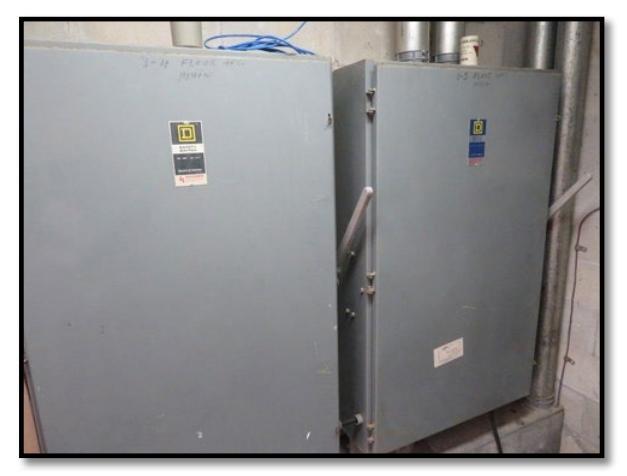
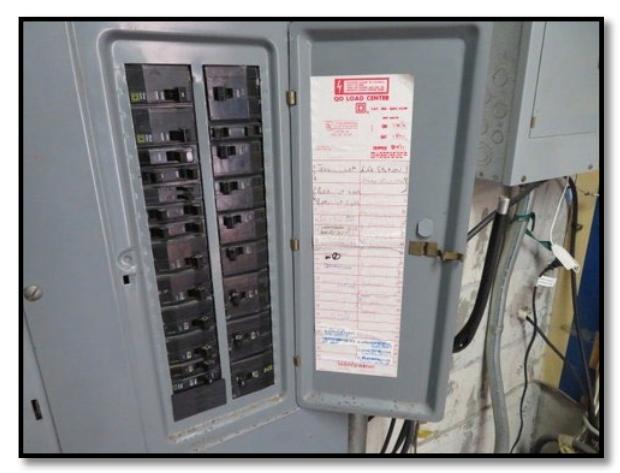
Figure 1

The common area electrical panels are primarily original, in fair operational condition and range in capacity. The useful life of these components is up to and often beyond 75 years. However, not all components will fail simultaneously. Therefore, we recommend the Association budget for partial repairs and replacement of the electrical systems beginning by 2028 and every 10 years thereafter.

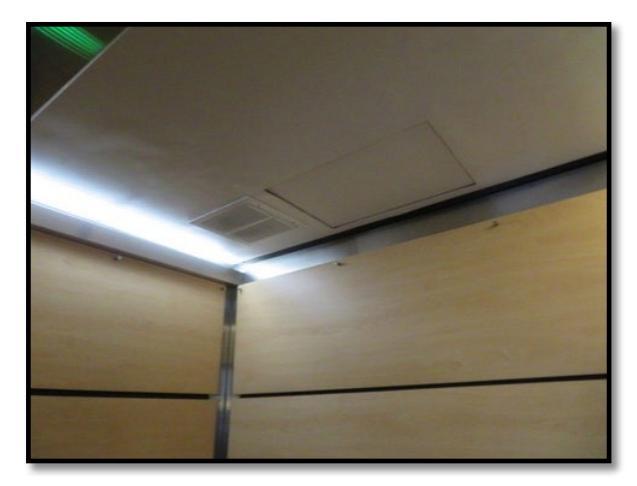
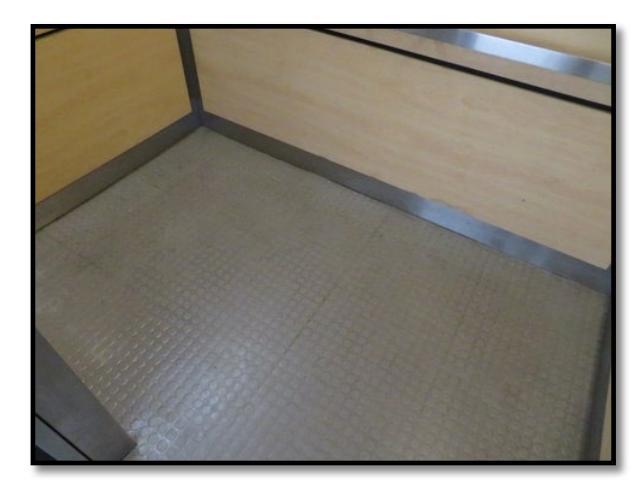
The Association maintains three elevators. The cab finishes comprise lighting, tile floors and wood panel walls. The cab finishes are in fair condition at an age of 21 years. Cab finishes have a useful life from 15- to 20-years. The Association should budget for replacements by 2028 and again by 2045.

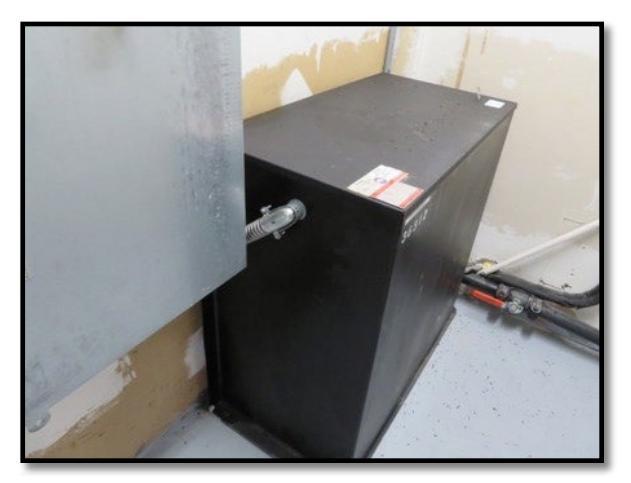
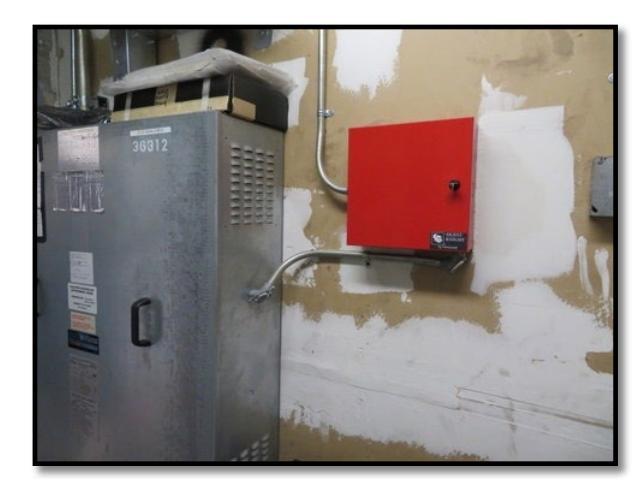
Figure 1 – Building B Equipment

Each of the three buildings utilizes a 2,500-pound capacity hydraulic elevator that serves four floors. Hydraulic elevator components include a cylinder, pump and controls. These components are original and in fair reported condition. The useful lives of these components vary up to 35 years. However, the Association should budget for replacements by 2028. The elevator's safety equipment should be brought up to the latest code. Fire service features should be brought up to accordance with the requirements of the applicable ASME A17.1, Safety Code for Elevators and Escalators. The Association should contract with an independent elevator consultant to develop specifications for elevator replacement proposals.

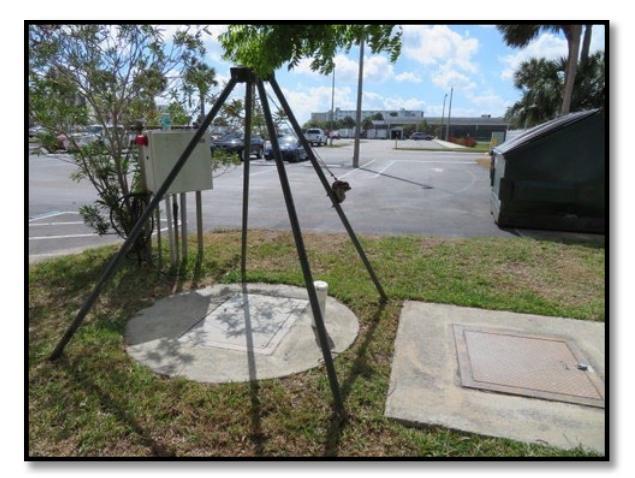
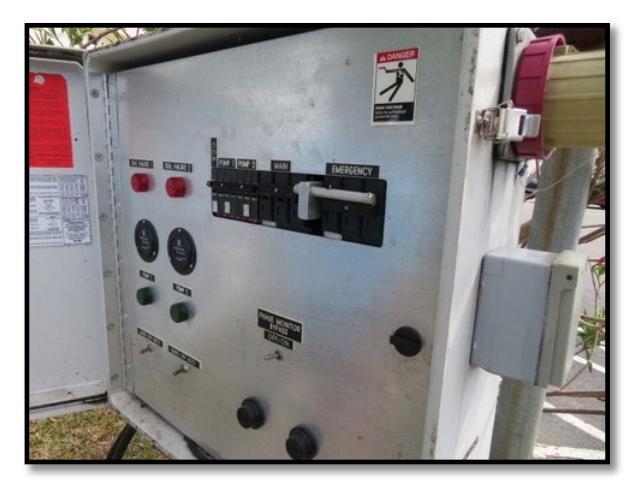
Figure 1

The Association maintains a lift station. A lift station typically comprises controls, two pumps and guide rails that require replacement. Lift stations require renovations every 30 years. The lift station was operational at the time of inspection. The exact age of each component is unknown. Pelican Point should budget for a renovation of the lift station by 2026. Interim replacement of pumps should be funded through the operating budget as needed.

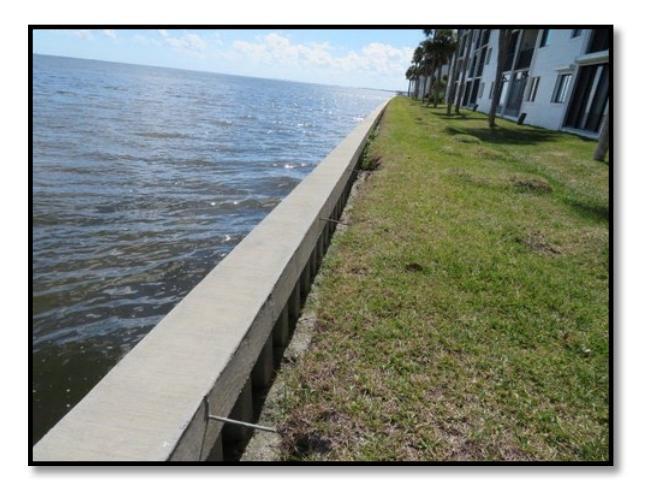
Pelican Point maintains approximately 1,210 linear feet of a vinyl panel sea wall with a concrete cap. The sea wall is in good condition overall at an age of five years. Significant areas of displacement around Building B are noted. Management reports that the Association plans to repair the sea wall through a special assessment. The cap encases the walls anchoring system and transfers the load and is an essential structural component of a sea wall. Sea walls of this type have a long useful life with the benefit of ongoing maintenance. Ongoing maintenance includes power washing and sealing the cap, filling the cracks with epoxy and partial replacements of the concrete as needed. Pelican Point should fund this maintenance activity through the operating budget. The Association should budget for partial replacements of up to seventy percent (70%) of the sea wall by 2053.

Figure 3 – Sea Wall Displacement

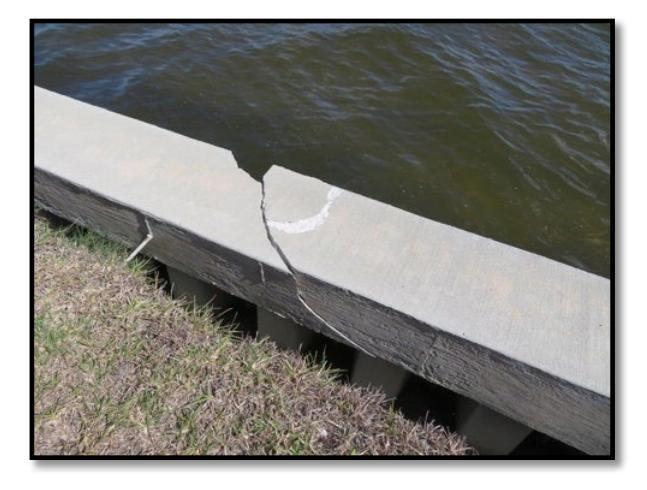
Figure 4 – Sea Wall Cap Cracks

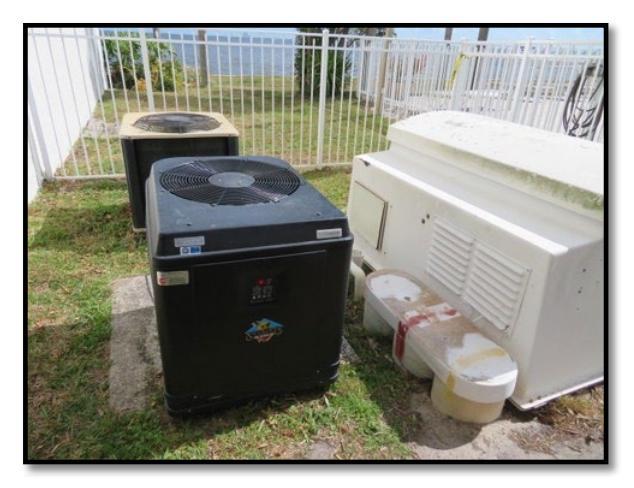
Figure 1 – Pool Hearers

Pelican Point maintains pool mechanical equipment. The mechanical equipment includes heaters, pumps, filters and chlorinators. The mechanical equipment is in fair overall condition at various ages. The pool equipment has a useful life from 5- to 10-years with the benefit of ongoing maintenance. This ongoing maintenance includes partial replacements of the pumps, filters and chlorinators as needed. The Association should fund these minor partial replacements through the operating budget. Pelican Point should budget for replacements by 2026 in conjunction with the pool finish.

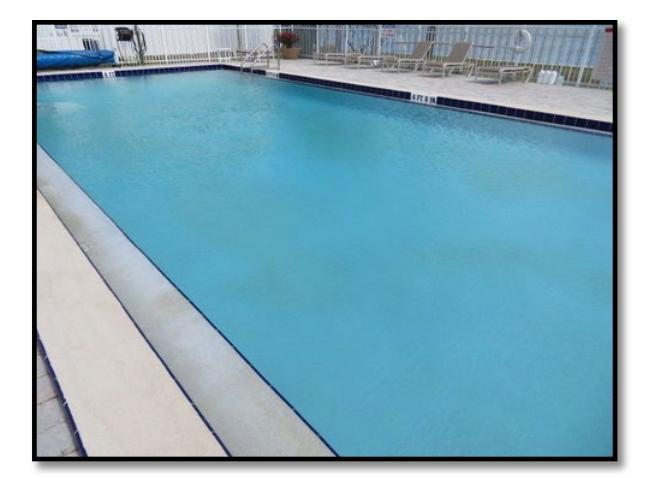
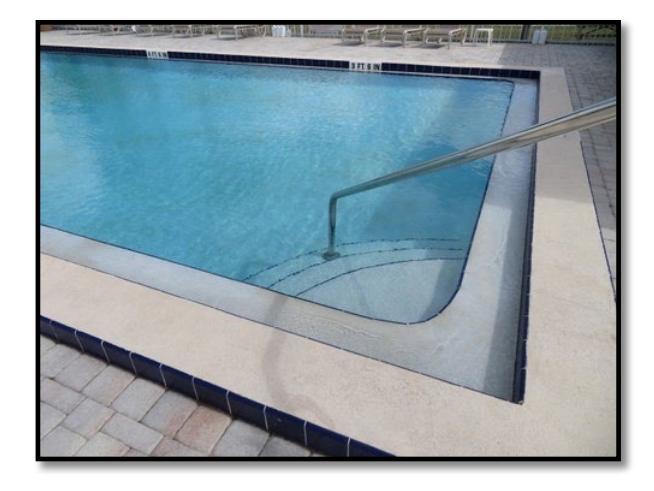
Figure 1

The Association maintains approximately 1,150 square feet of horizontal pool finish. The pool finish is in fair overall condition at an age of seven years. The pool finish has a useful life from 10- to 15-years. Pelican Point should budget for resurfacing of the pool finish by 2026 and every 10 years thereafter. Typically minor upgrades will be needed to bring the pool up to current code. The Association should ensure that bidding contractors have an active license with a "CPC" designation. An allowance for replacement of the waterline tile is included in the estimate of cost. Potential repairs to the underlying pool structure may raise the estimate of cost.
