Island Cove Condominium Association 343 N Tropical Trail, Merritt Island, FL 32953

Existing Building - Milestone Inspection Report Phase One

RE: Island Cove Condominium – Milestone Inspection Report 343 N Tropical Trail, Merritt Island, FL 32953 KEG File # 22FD-0976

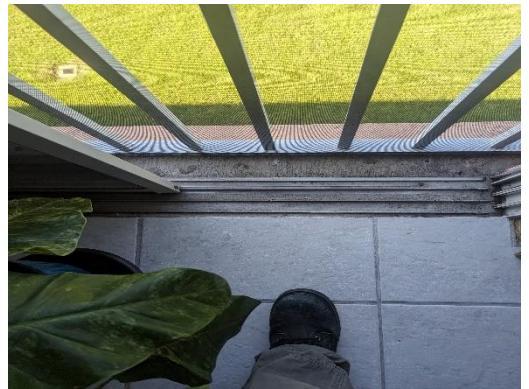
From our observation the balcony decks have different types of cover. Due to its proximity to the water, it is recommended to have a waterproofing system that will prevent salt entering the concrete and cause deterioration. At the time of our observations, we observed units with carpets, tiles, or paint on the balcony floors.

Photo 1: Tile on Balcony.

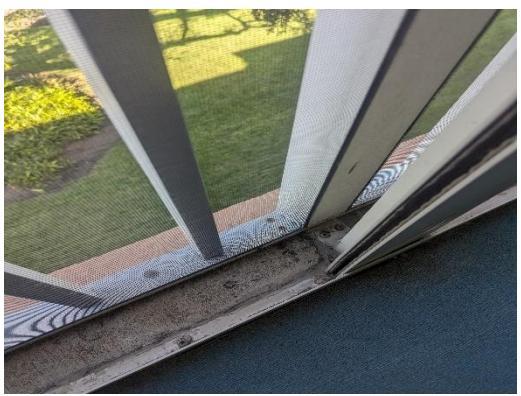
Photo 3: Screen enclosure at balcony

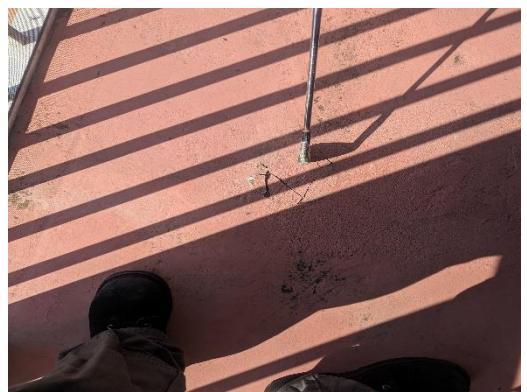
Photo 5: Acrylic Paint on balcony floor

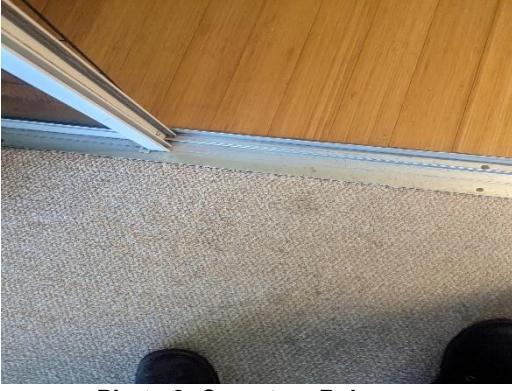
Photo 2: Carpet on Balcony.

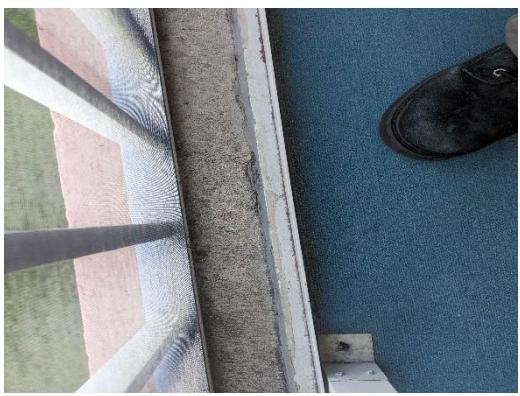
No concrete deterioration was observed that required a phase 2 evaluation. However, minor concrete spalling and delaminated topping was observed at balcony that would require proper correction to extend the life of the structure. As explained in Section 4.3, minor concrete repairs will be required on the next restoration cycle.

Photo 4: Section of exposed concrete

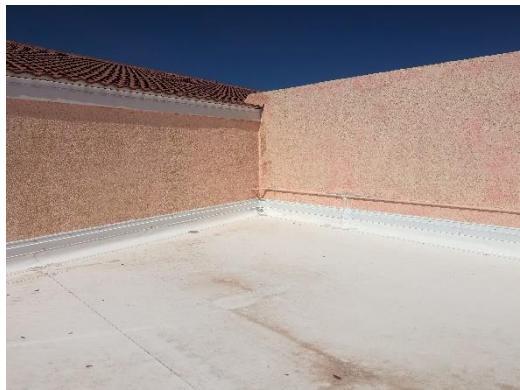
Island Cove Condominium has a tile hip roof with valley and a flat roof section at the entrance of the building. The roof does not show any kind of deterioration and no leaks have been reported. According to the information provided the roof was replaced in December 2022.

Photo 6: View of flat roof.

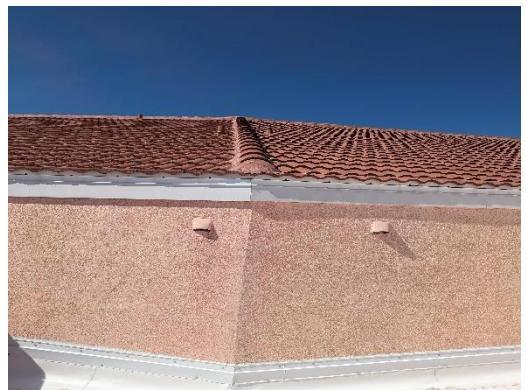
Photo 7: View of tyle roof

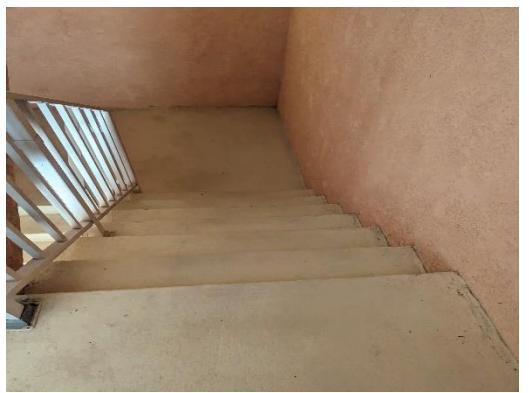
Photo 9: View of Staircase, Typical.

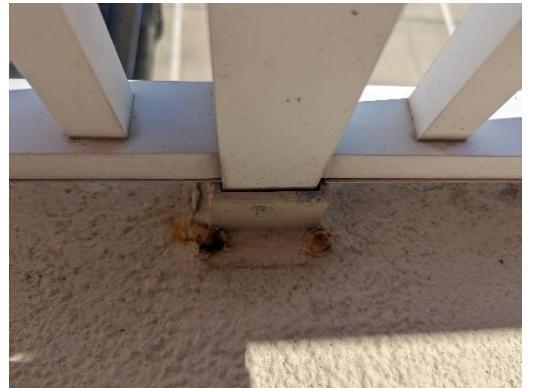
The guardrail at the balconies appears to be in good condition, however rust was observed on some of the screws and surface rust marks were visible on some of the rails. No information has been provided regarding replacement or repair of the guardrails.

Photo 11: Rusted fasteners at walkway guardrails.

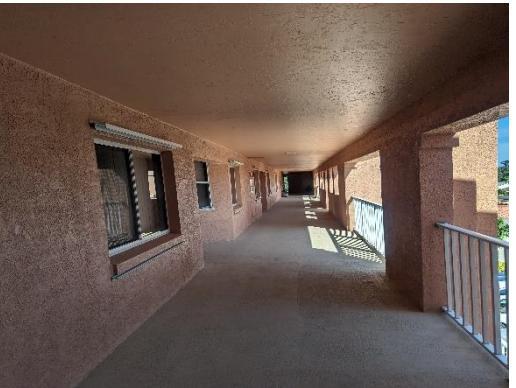
Photo 8: View of Walkway, Typical

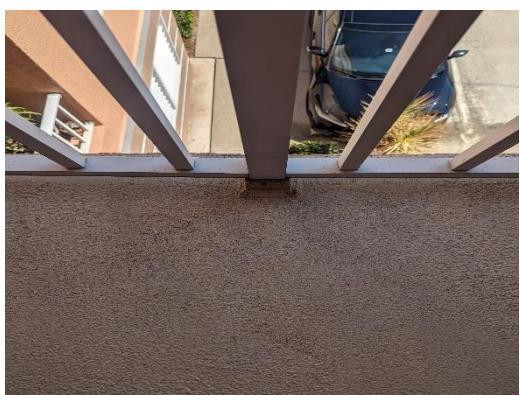
Photo 10: View of guardrail at walkways

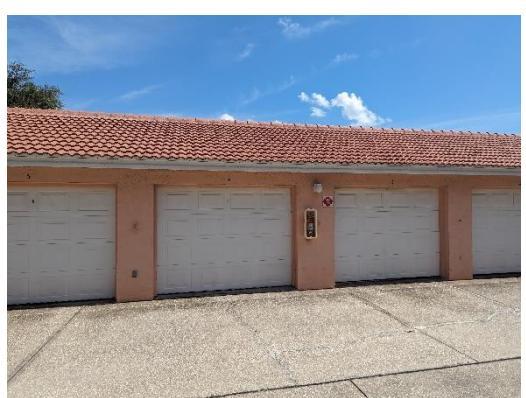
Additional observations were made to the exterior road and garage. These areas are not part of the new legislation. From our observations no major issues were found. The concrete deck is a slab on grade and shows signs of cracks which are typical for the location and type of construction.

Photo 12: Typical Garage

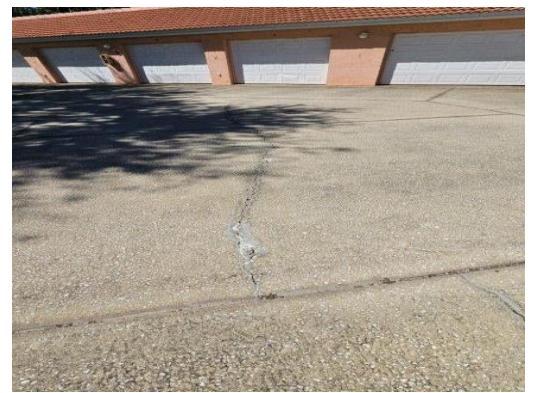
Photo 13: Typical Crack on concrete slab

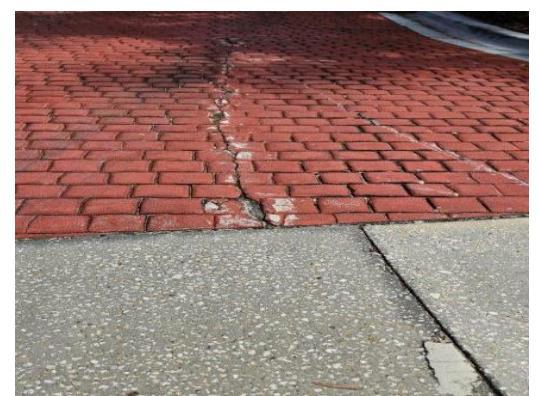
Photo 14: Crack on stamp concrete
