# Uniform Mitigation Verification Inspection Form

| Inspection Date: 12/15/2022 | | |
| Owner Name: Club Hacienda Condominium Association | | Contact Person: |
| Address: 1019-1047 Country Club Dr, Building 4 | | Home Phone: |

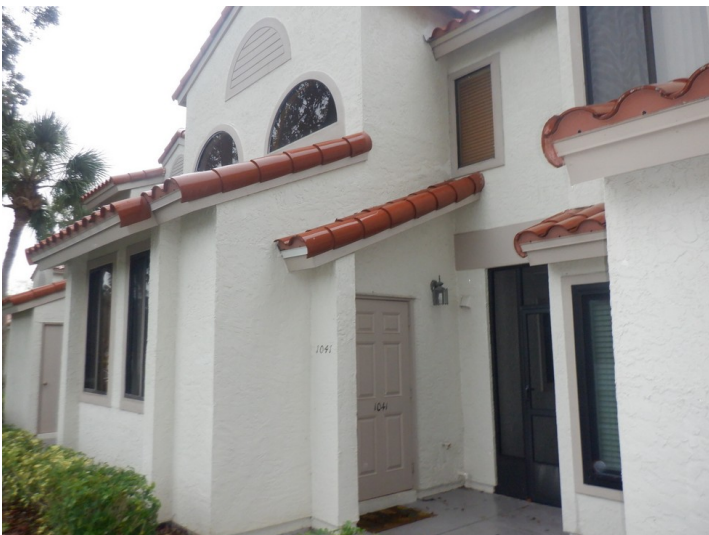
| Opening Protection Level Chart<br>Place an "X" in each row to identify all forms of protection in use for each opening type. Check only one answer below (A thru X), based on the weakest form of protection (lowest row) for any of the Glazed openings and indicate the weakest form of protection (lowest row) for Non-Glazed openings. | | Glazed Openings | | | | Non-Glazed Openings | |
|--|---|---|---|---|---|---|---|
| X | No Windborne Debris Protection | X | | | | X | |

No openings protected

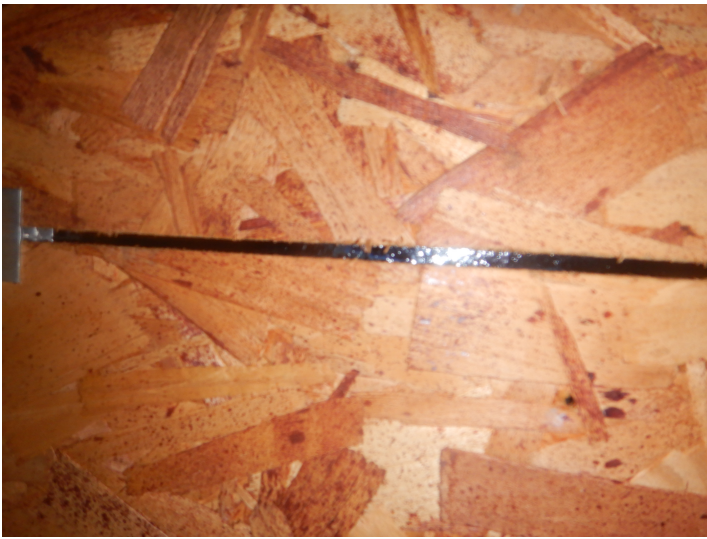
- A. SWR (also called Sealed Roof Deck) Self-adhering polymer modified-bitumen roofing underlayment applied directly to the sheathing or foam adhesive SWR barrier (not foamed-on insulation) applied as a supplemental means to protect the dwelling from water intrusion in the event of roof covering loss.
- B. No SWR.
- C. Unknown or undetermined.

SWR

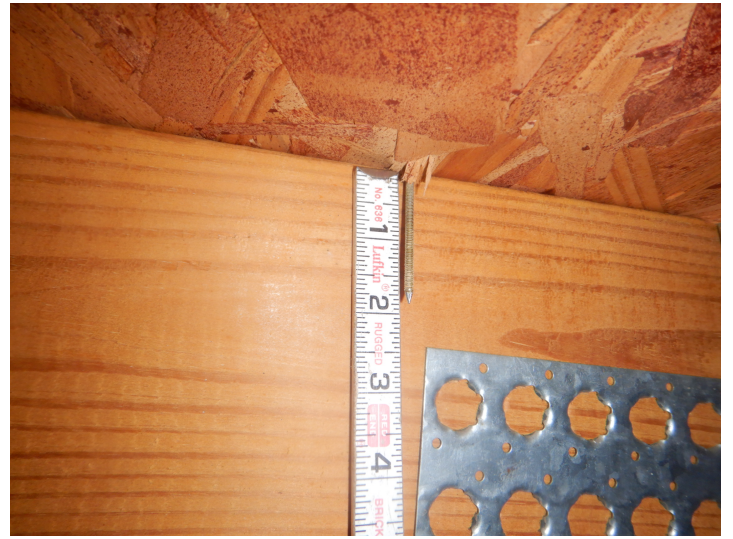
8D NAILS

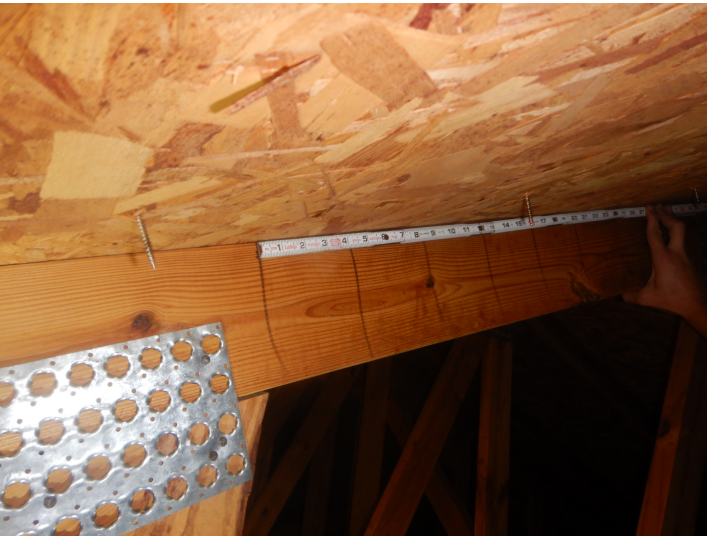
- C. Plywood/OSB roof sheathing with a minimum thickness of 7/16" inch attached to the roof truss/rafter (spaced a maximum of 24" inches o.c.) by 8d common nails spaced a maximum of 6" inches in the field. -OR- Dimensional lumber/Tongue & Groove decking with a minimum of 2 nails per board (or 1 nail per board if each board is equal to or less than 6 inches in width). -OR- Any system of screws, nails, adhesives, other deck fastening system or truss/rafter spacing that is shown to have an equivalent

6X6 NAIL PATTERN

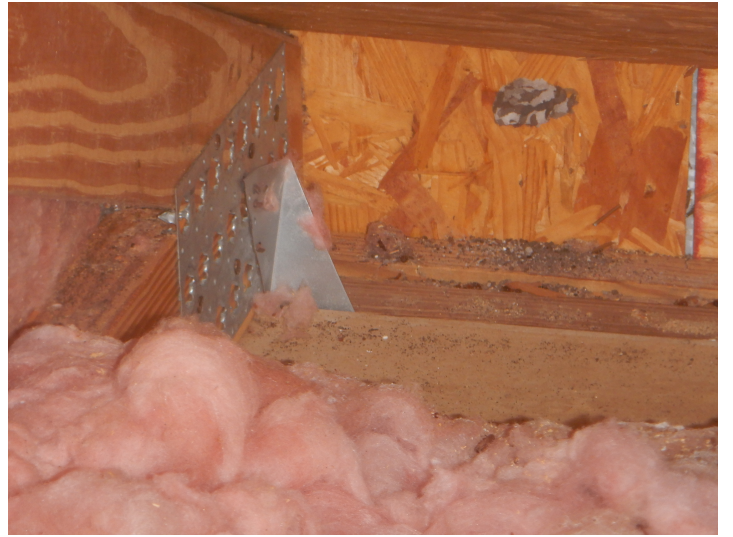
- B. Clips
  - Metal connectors that do not wrap over the top of the truss/rafter, **or**
  - Metal connectors with a minimum of 1 strap that wraps over the top of the truss/rafter and does not meet the nail position requirements of C or D, but is secured with a minimum of 3 nails.
- C. Single Wraps

CLIPS 3 NAILS
