COMMERCIAL WINDSTORM MITIGATION
INSPECTION REPORT (OIR-B1-1802)

Banana Bay Condominium

200 Banana River Blvd S, Building 1000, Units 1001-1004
Cocoa Beach, FL 32931

As of 5/20/2022

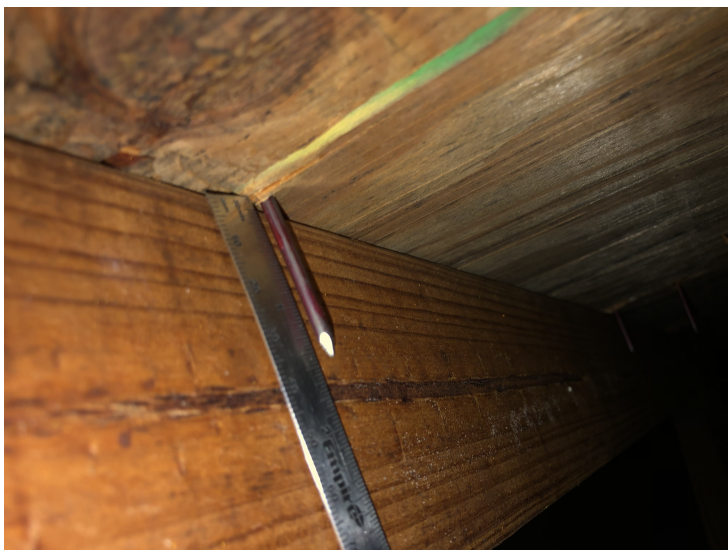
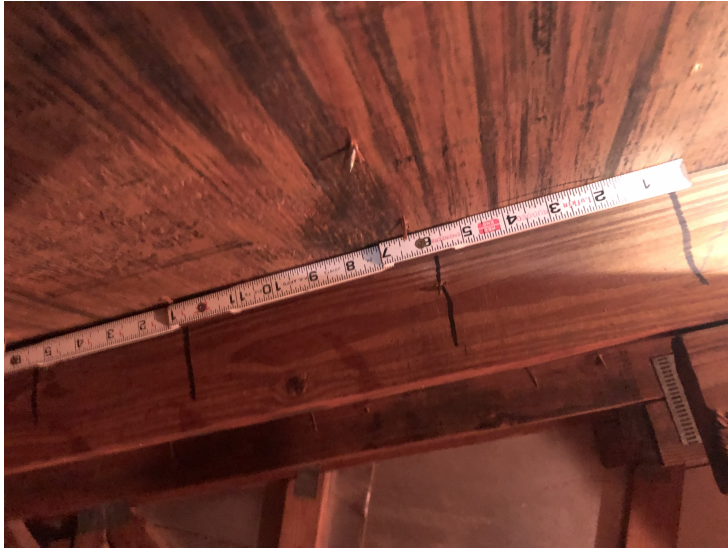
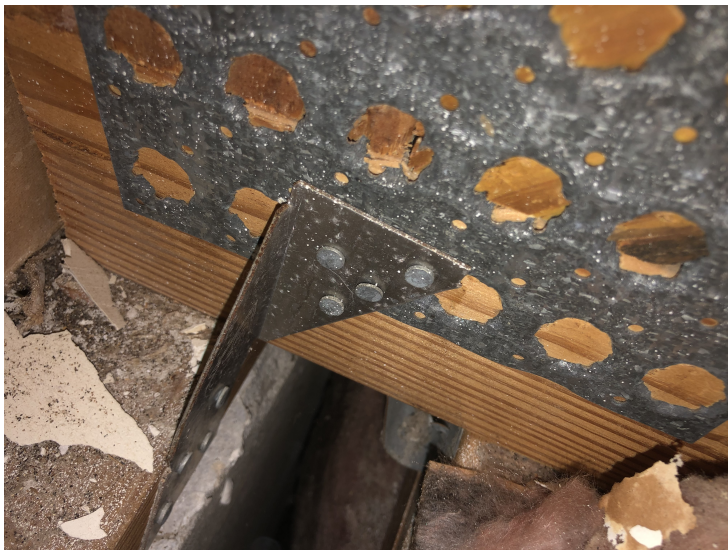
Roof Construction

- 3. Roof Deck Attachment:** **Level C**
Comments: Inspection verified 1/2" plywood roof deck attached with 8d nails at a minimum 6" on the edge & 6" in the field.

- 4. Roof to Wall Attachment:** **Clips**
Comments: Inspection verified hurricane clips fastened with a minimum of three nails.
- 5. Roof Geometry:** **Other Roof**
Comments: Inspection verified hip and gable roof shapes. The gable sections of the roof account for greater than 10% of the total roof perimeter.
