# COMMERCIAL WINDSTORM MITIGATION INSPECTION REPORT (OIR-B1-1802)

## Banana Bay Condominium

200 Banana River Blvd S, Building 1200, Units 1201-1204  
Cocoa Beach, FL 32931

As of 5/20/2022

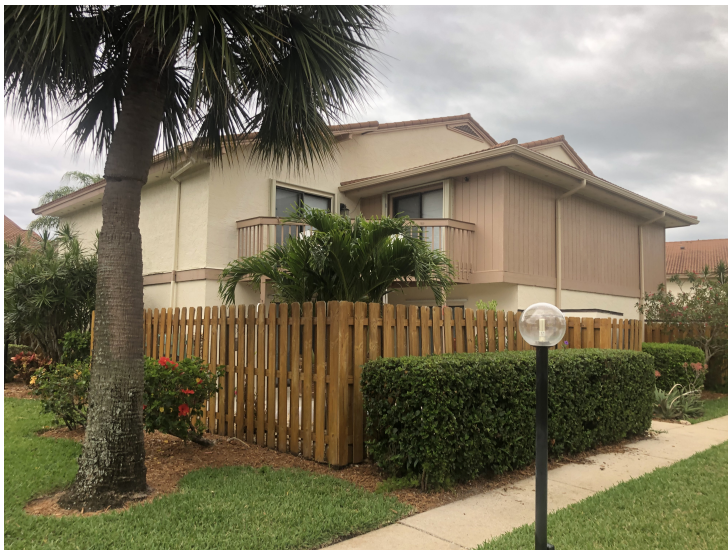
Exterior Elevation

| <b>5. <u>Roof Geometry:</u></b><br>Comments: | <b>Other Roof</b><br>Inspection verified hip and gable roof shapes. The gable sections of the roof account for greater than 10% of the total roof perimeter. |

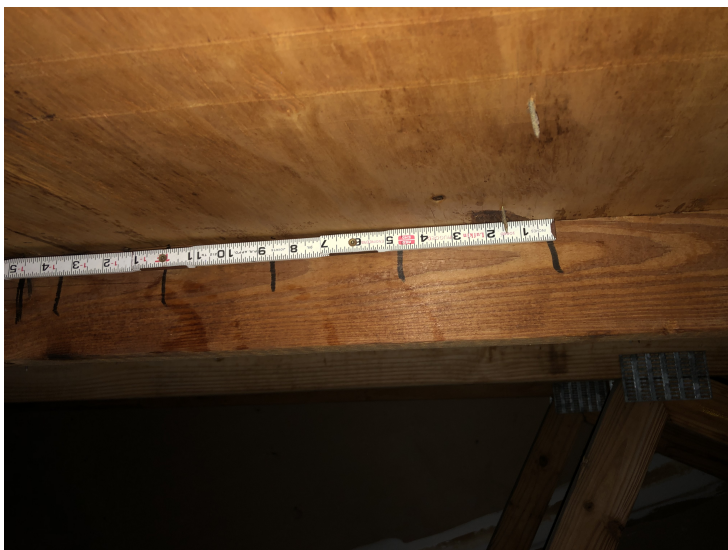
Roof Construction

| <b>3. <u>Roof Deck Attachment:</u></b><br>Comments: | <b>Level C</b><br>Inspection verified 1/2" plywood roof deck attached with 8d nails at a minimum 6" on the edge & 6" in the field. |

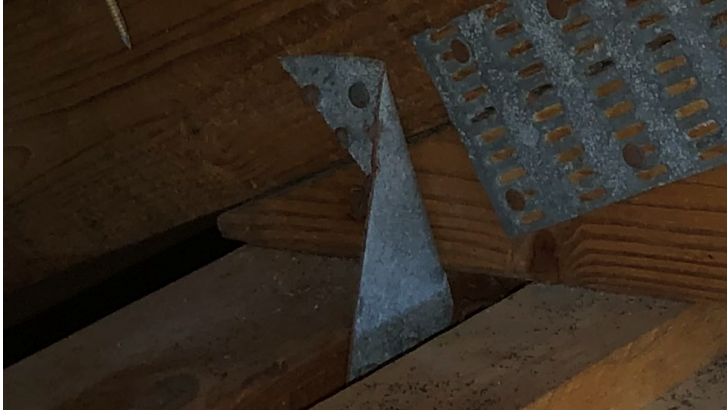
Roof Construction

| <b>4. <u>Roof to Wall Attachment:</u></b><br>Comments: | <b>Clips</b><br>Inspection verified hurricane clips fastened with a minimum of three nails. |
