COMMERCIAL WINDSTORM MITIGATION
INSPECTION REPORT (OIR-B1-1802)

Banana Bay Condominium

200 Banana River Blvd S, Building 1500, Units 1501-1504
Cocoa Beach, FL 32931

As of 5/20/2022

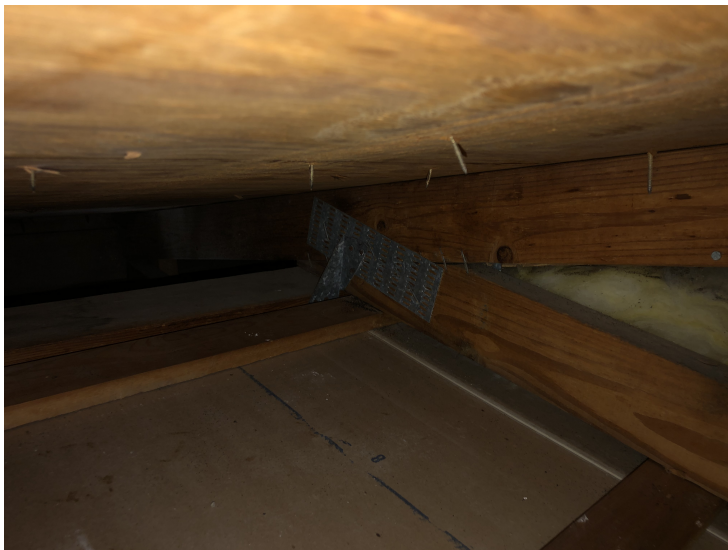
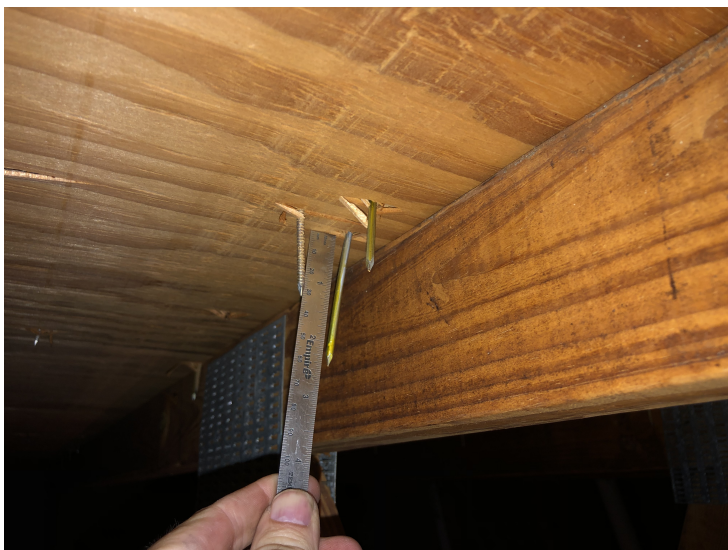
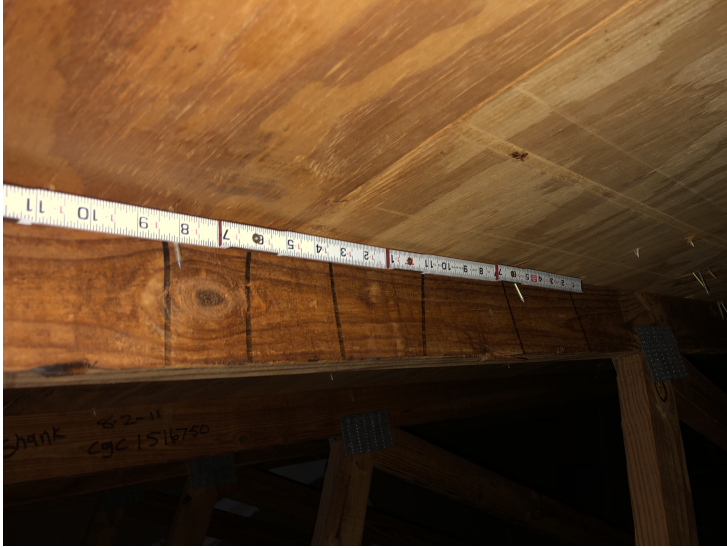
Roof Construction

- 3. Roof Deck Attachment:** **Level C**
Comments: Inspection verified 1/2" plywood roof deck attached with 8d nails at a minimum 6" on the edge & 6" in the field.

- 4. Roof to Wall Attachment:** **Clips**
Comments: Inspection verified hurricane clips fastened with a minimum of three nails.
- 5. Roof Geometry:** **Other Roof**
Comments: Inspection verified hip and gable roof shapes. The gable sections of the roof account for greater than 10% of the total roof perimeter.
