COMMERCIAL WINDSTORM MITIGATION INSPECTION REPORT (OIR-B1-1802)

Banana Bay Condominium

200 Banana River Blvd S, Building 1600, Units 1601-1604
Cocoa Beach, FL 32931

As of 5/20/2022

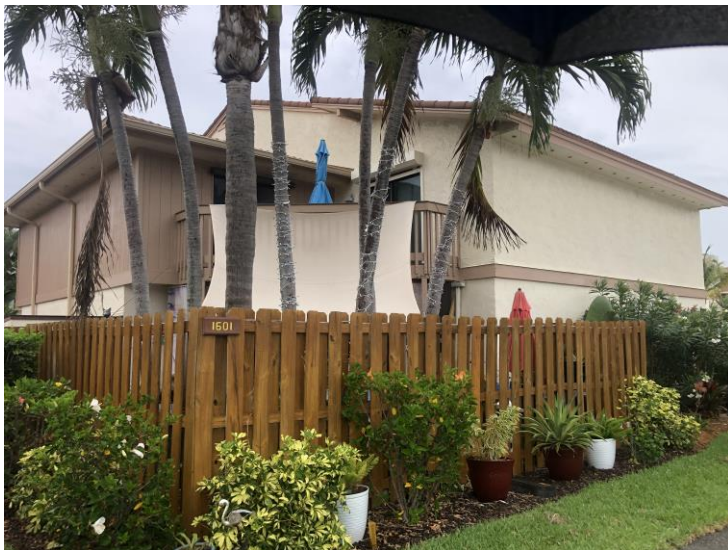
Exterior Elevation

- 4. Roof to Wall Attachment:** **Clips**
Comments: Inspection verified hurricane clips fastened with a minimum of three nails.
- 5. Roof Geometry:** **Other Roof**
Comments: Inspection verified hip and gable roof shapes. The gable sections of the roof account for greater than 10% of the total roof perimeter.

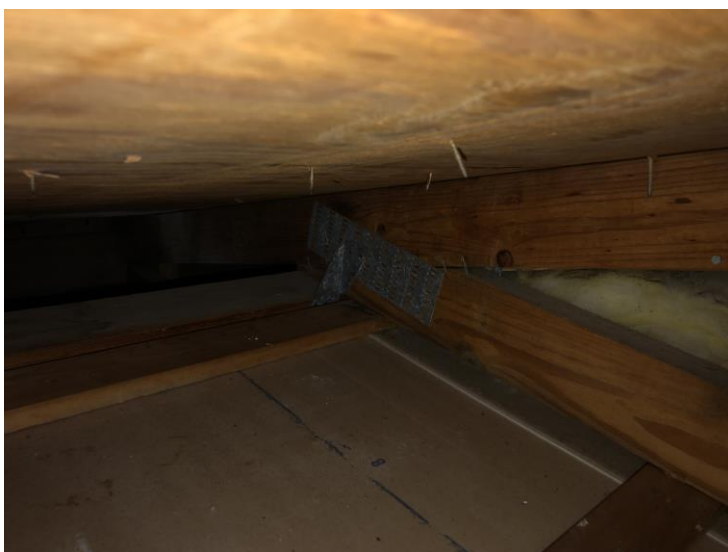
Roof Construction

- 3. Roof Deck Attachment:** **Level C**
Comments: Inspection verified 1/2" plywood roof deck attached with 8d nails at a minimum 6" on the edge & 6" in the field.
