COMMERCIAL WINDSTORM MITIGATION
INSPECTION REPORT (OIR-B1-1802)

Banana Bay Condominium
200 Banana River Blvd S, Building 1900, Units 1901-1904
Cocoa Beach, FL 32931

As of 5/20/2022

RECAPITULATION OF MITIGATION FEATURES
For 200 Banana River Blvd S, Building 1900, Units 1901-1904

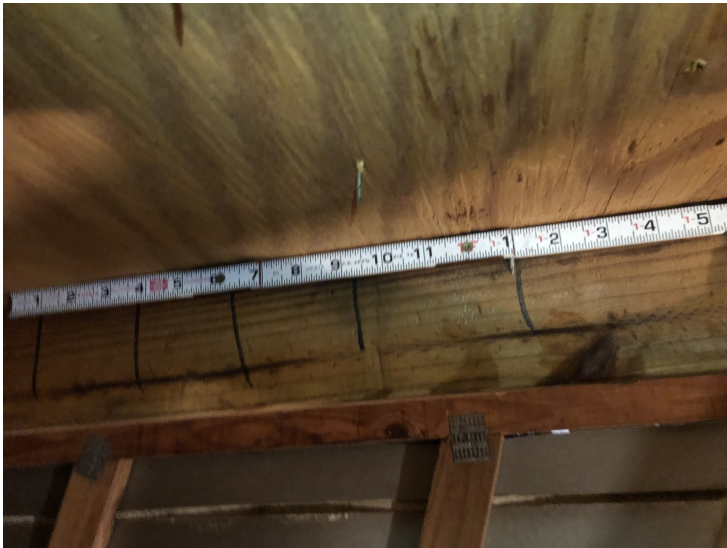
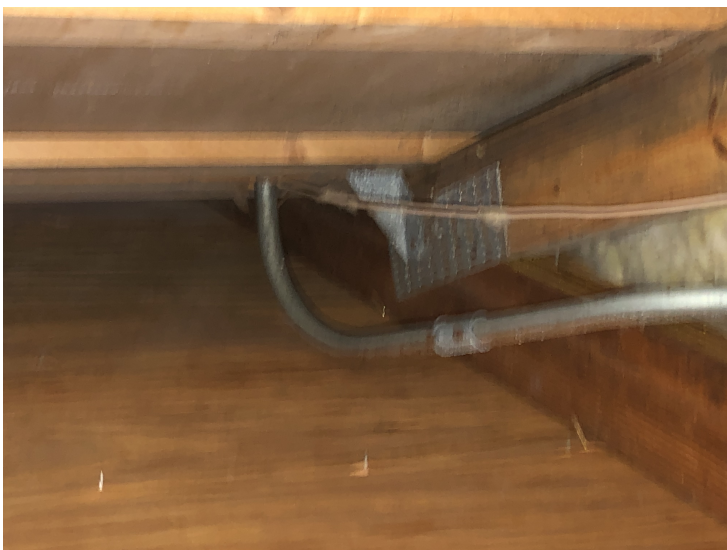
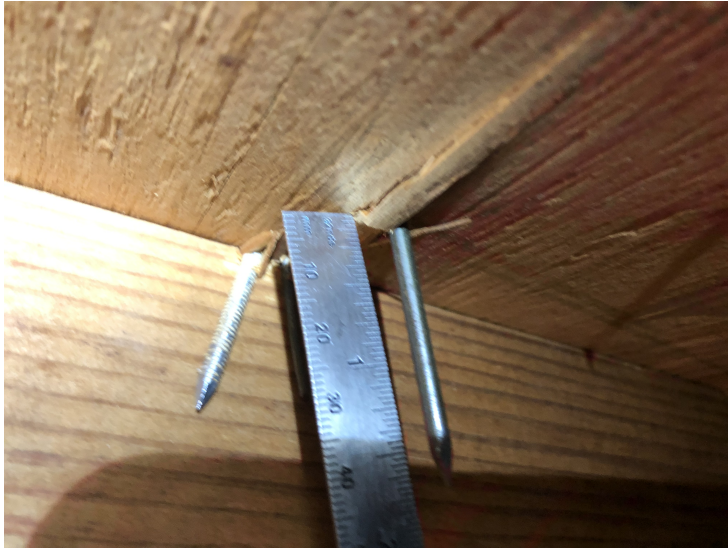
Roof Construction

- 3. Roof Deck Attachment:** **Level C**
Comments: Inspection verified 1/2" plywood roof deck attached with 8d nails at a minimum 6" on the edge & 6" in the field.

- 4. Roof to Wall Attachment:** **Clips**
Comments: Inspection verified hurricane clips fastened with a minimum of three nails.
- 5. Roof Geometry:** **Other Roof**
Comments: Inspection verified hip and gable roof shapes. The gable sections of the roof account for greater than 10% of the total roof perimeter.
