COMMERCIAL WINDSTORM MITIGATION
INSPECTION REPORT (OIR-B1-1802)

Banana Bay Condominium

200 Banana River Blvd S, Building 200, Units 201-204
Cocoa Beach, FL 32931

As of 5/20/2022

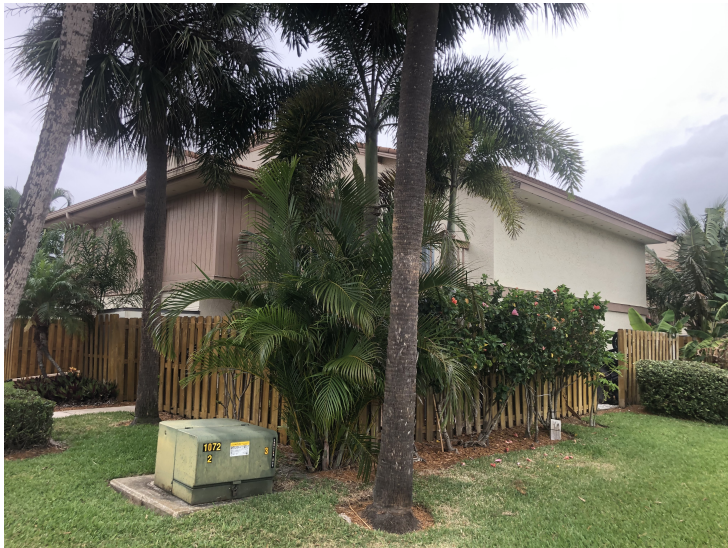
Exterior Elevation

- 4. Roof to Wall Attachment:** **Clips**
Comments: Inspection verified hurricane clips fastened with a minimum of three nails.
- 5. Roof Geometry:** **Other Roof**
Comments: Inspection verified hip and gable roof shapes. The gable sections of the roof account for greater than 10% of the total roof perimeter.

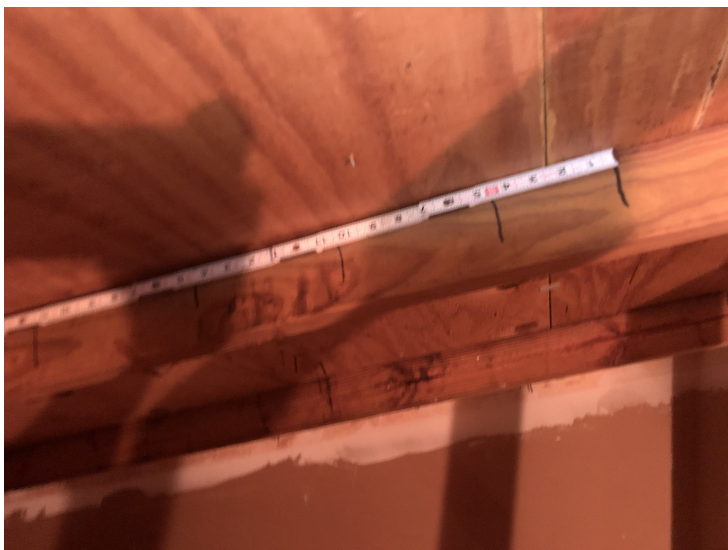
Roof Construction

- 3. Roof Deck Attachment:** **Level C**
Comments: Inspection verified 1/2" plywood roof deck attached with 8d nails at a minimum 6" on the edge & 6" in the field.
