COMMERCIAL WINDSTORM MITIGATION
INSPECTION REPORT (OIR-B1-1802)

Banana Bay Condominium

200 Banana River Blvd S, Building 2100, Units 2101-2104
Cocoa Beach, FL 32931

As of 5/20/2022

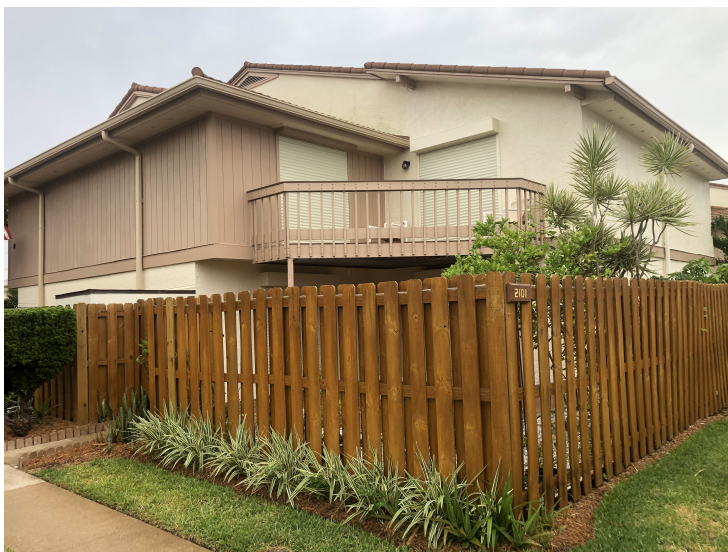
Exterior Elevation

- 4. Roof to Wall Attachment:** **Toe Nails**
Comments: Toe nails were verified during our attic inspection as the roof wall connection.
- 5. Roof Geometry:** **Other Roof**
Comments: Inspection verified hip and gable roof shapes. The gable sections of the roof account for greater than 10% of the total roof perimeter.

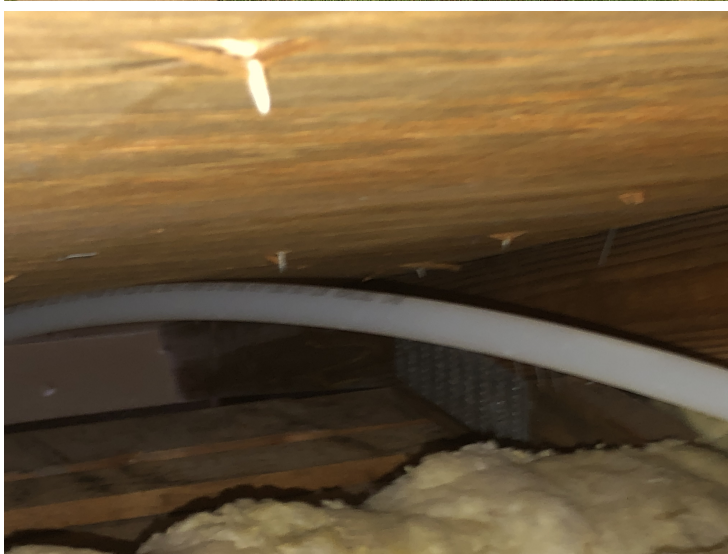
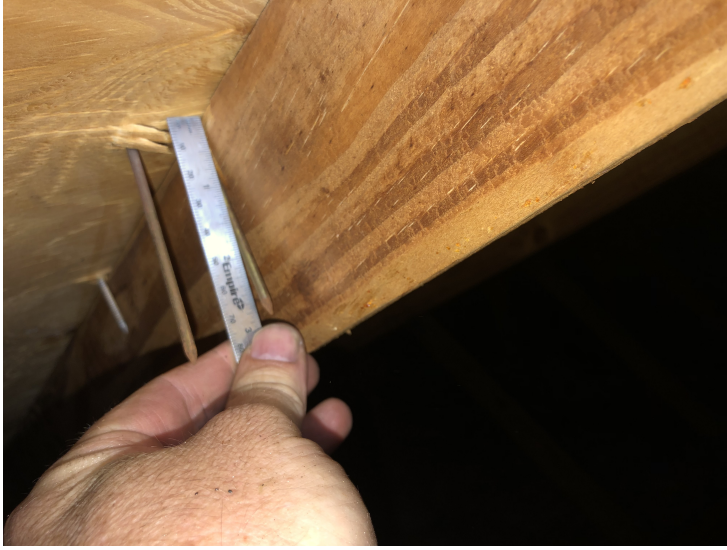
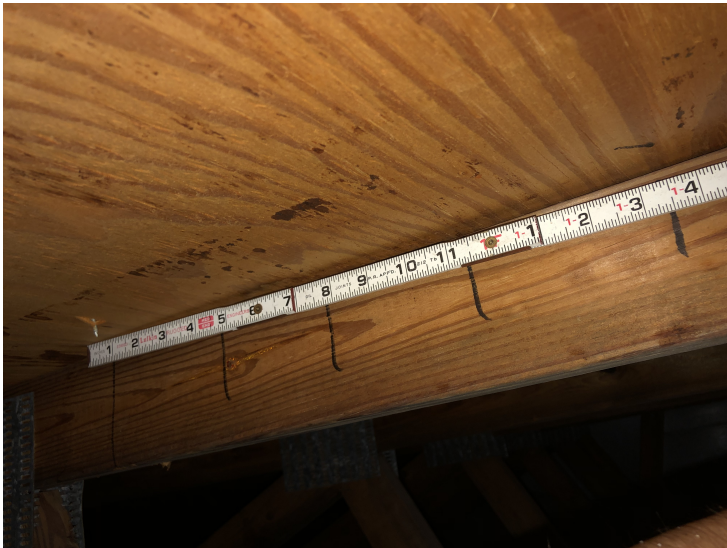
Roof Construction

- 3. Roof Deck Attachment:** **Level B**
Comments: Inspection verified 1/2" plywood roof deck attached with 8d nails at a minimum of 6" on the edge & 12" in the field.
