COMMERCIAL WINDSTORM MITIGATION INSPECTION REPORT (OIR-B1-1802)

Banana Bay Condominium

200 Banana River Blvd S, Building 300, Units 301-304
Cocoa Beach, FL 32931

As of 5/20/2022

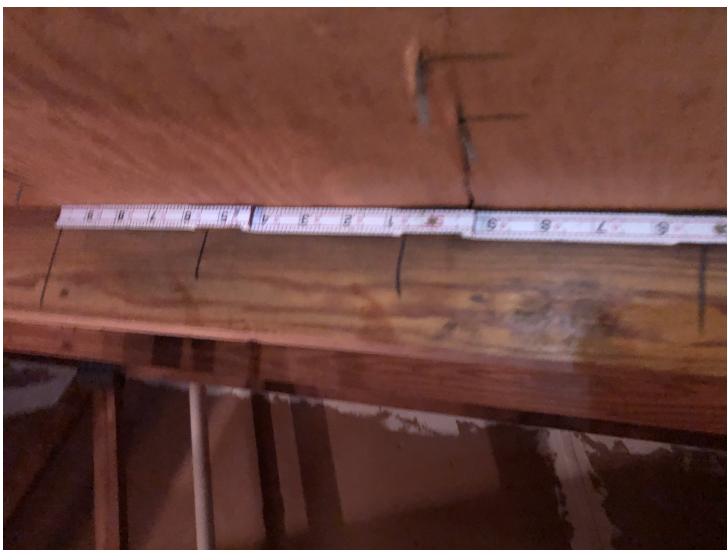
Roof Construction

- 3. Roof Deck Attachment:** **Level C**
Comments: Inspection verified 1/2" plywood roof deck attached with 8d nails at a minimum 6" on the edge & 6" in the field.
