COMMERCIAL WINDSTORM MITIGATION
INSPECTION REPORT (OIR-B1-1802)

Banana Bay Condominium

200 Banana River Blvd S, Building 500, Units 501-504
Cocoa Beach, FL 32931

As of 5/20/2022

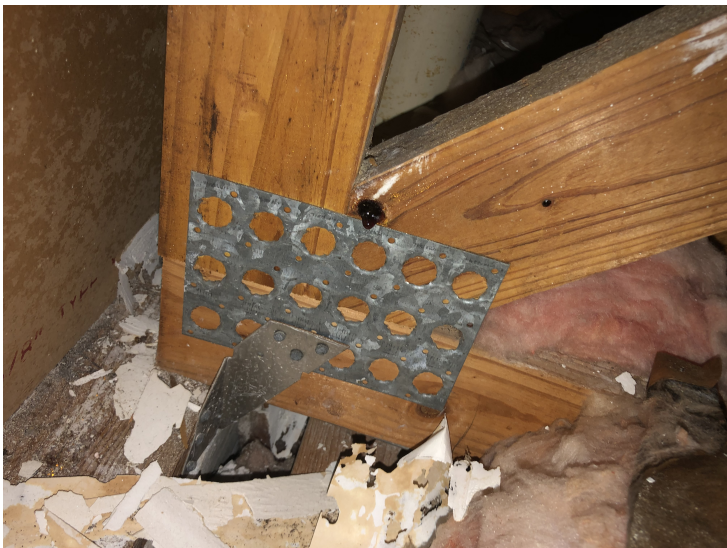
Roof Construction

- 3. Roof Deck Attachment:** **Level C**
Comments: Inspection verified 1/2" plywood roof deck attached with 8d nails at a minimum 6" on the edge & 6" in the field.

- 4. Roof to Wall Attachment:** **Clips**
Comments: Inspection verified hurricane clips fastened with a minimum of three nails.
- 5. Roof Geometry:** **Other Roof**
Comments: Inspection verified hip and gable roof shapes. The gable sections of the roof account for greater than 10% of the total roof perimeter.
