COMMERCIAL WINDSTORM MITIGATION
INSPECTION REPORT (OIR-B1-1802)

Banana Bay Condominium

200 Banana River Blvd S, Building 600, Units 601-604
Cocoa Beach, FL 32931

As of 5/20/2022

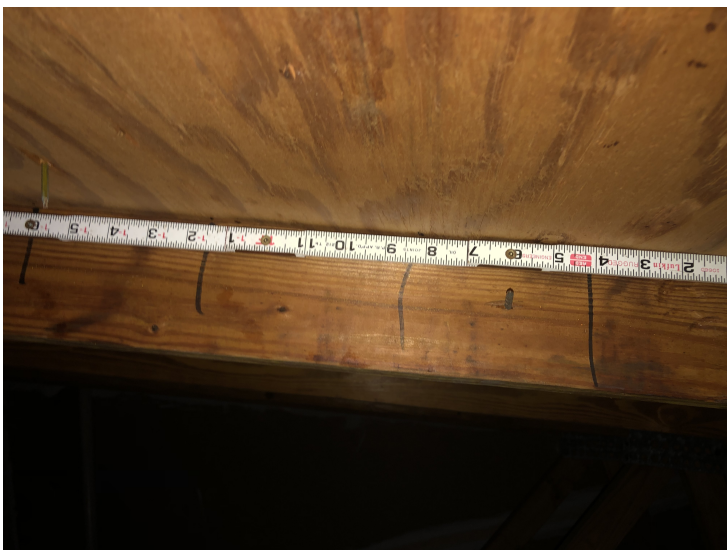
Roof Construction

- 3. Roof Deck Attachment:** **Level C**
Comments: Inspection verified 1/2" plywood roof deck attached with 8d nails at a minimum 6" on the edge & 6" in the field.

- 4. Roof to Wall Attachment:** **Clips**
Comments: Inspection verified hurricane clips fastened with a minimum of three nails.
- 5. Roof Geometry:** **Other Roof**
Comments: Inspection verified hip and gable roof shapes. The gable sections of the roof account for greater than 10% of the total roof perimeter.
