COMMERCIAL WINDSTORM MITIGATION  
INSPECTION REPORT (OIR-B1-1802)

Banana Bay Condominium

200 Banana River Blvd S, Building 700, Units 701-704  
Cocoa Beach, FL 32931

As of 5/20/2022

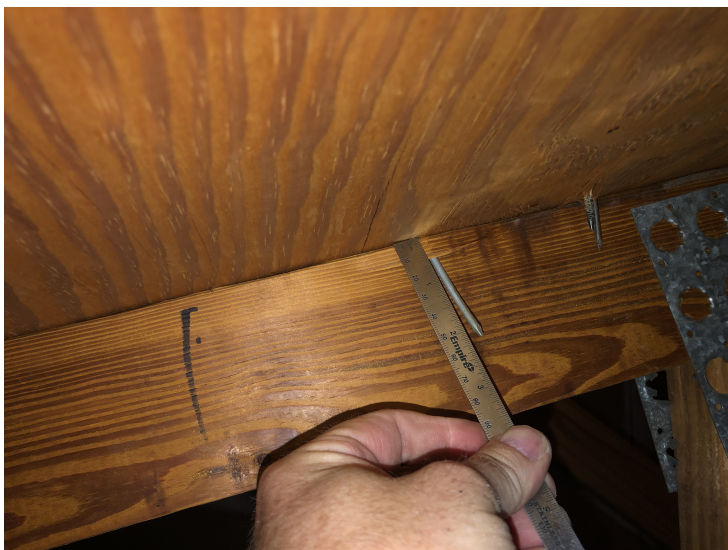
Roof Construction

- 3. Roof Deck Attachment:** **Level C**  
Comments: Inspection verified 1/2" plywood roof deck attached with 8d nails at a minimum 6" on the edge & 6" in the field.

- 4. Roof to Wall Attachment:** **Clips**  
Comments: Inspection verified hurricane clips fastened with a minimum of three nails.
- 5. Roof Geometry:** **Other Roof**  
Comments: Inspection verified hip and gable roof shapes. The gable sections of the roof account for greater than 10% of the total roof perimeter.
