COMMERCIAL WINDSTORM MITIGATION  
INSPECTION REPORT (OIR-B1-1802)

Banana Bay Condominium

200 Banana River Blvd S, Building 900, Units 901-904  
Cocoa Beach, FL 32931

As of 5/20/2022

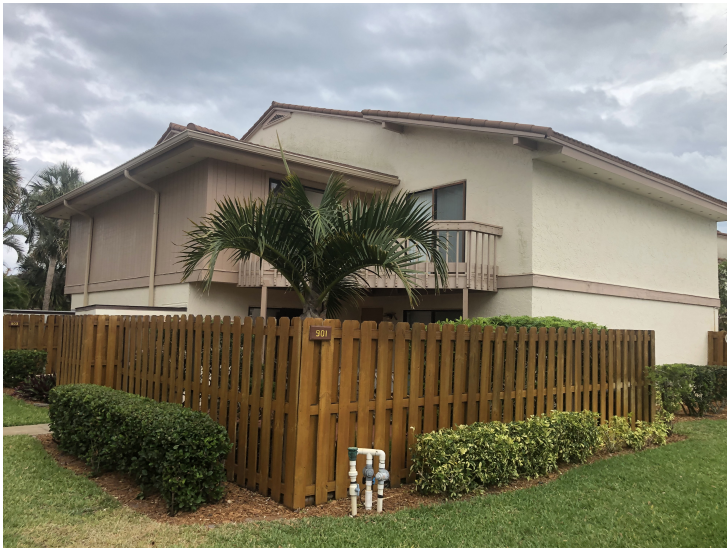
Exterior Elevation

- 4. Roof to Wall Attachment:** **Clips**  
Comments: Inspection verified hurricane clips fastened with a minimum of three nails.
- 5. Roof Geometry:** **Other Roof**  
Comments: Inspection verified hip and gable roof shapes. The gable sections of the roof account for greater than 10% of the total roof perimeter.

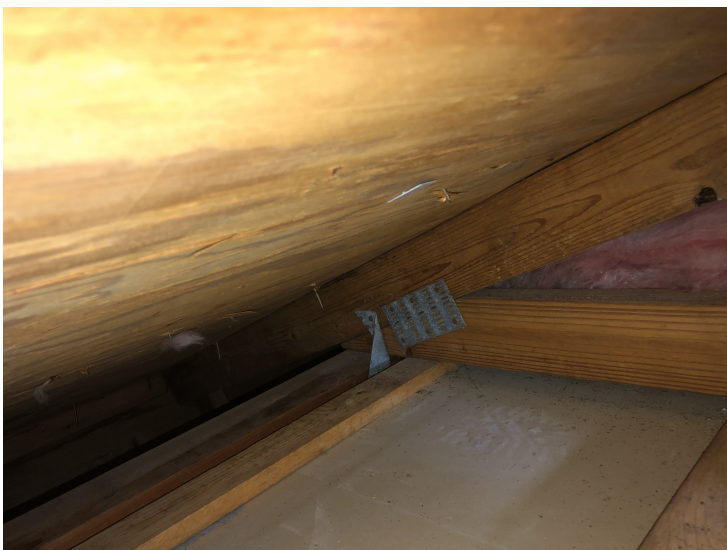
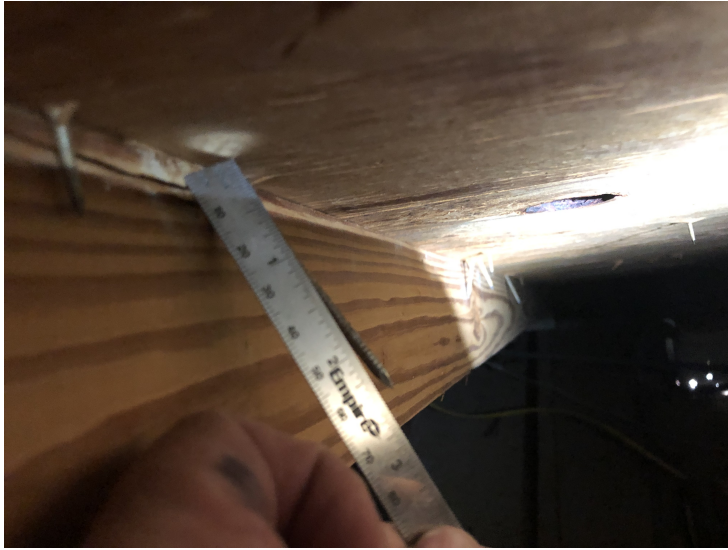
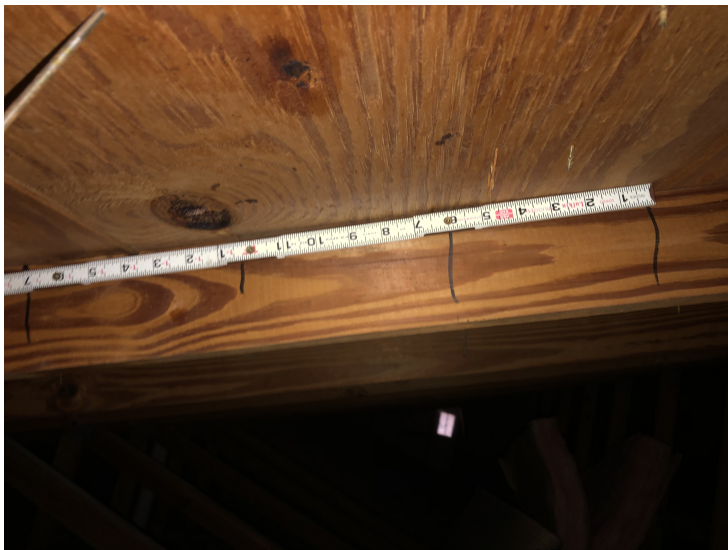
Roof Construction

- 3. Roof Deck Attachment:** **Level C**  
Comments: Inspection verified 1/2" plywood roof deck attached with 8d nails at a minimum 6" on the edge & 6" in the field.
