COMMERCIAL WINDSTORM MITIGATION INSPECTION REPORT (OIR-B1-1802)

Banana Bay Condominium
200 Banana River Blvd S, Clubhouse
Cocoa Beach, FL 32931

As of 5/20/2022

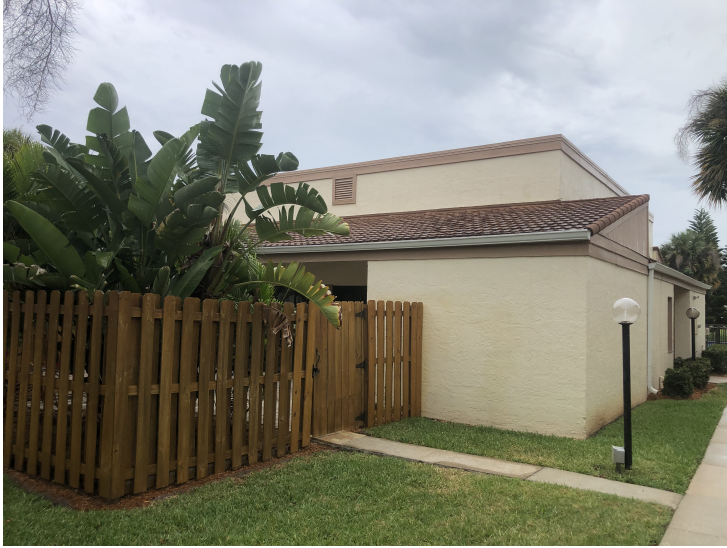
Exterior Elevation

- 1. Building Code:** **Unknown or does not meet the requirements of Answer A or B**
Comments: The year of construction was verified as +/- 1980 per Brevard County Property Appraiser.

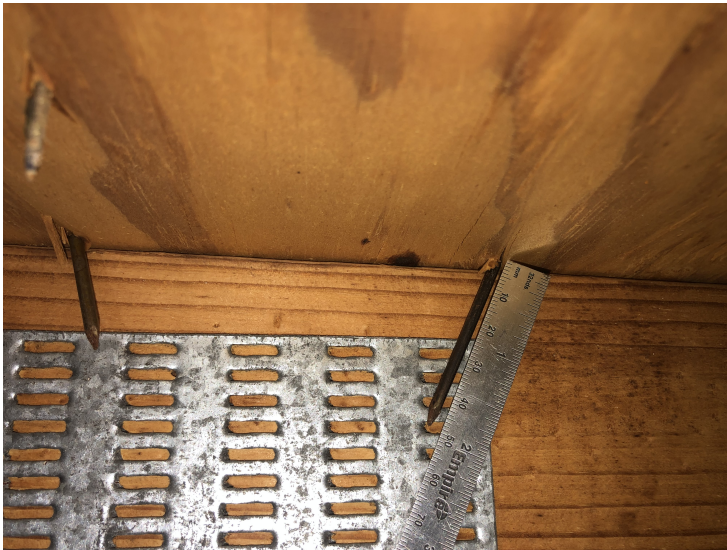
Roof Construction

- 3. Roof Deck Attachment:** **Level B**
Comments: Inspection verified 1/2" plywood roof deck attached with 8d nails at a minimum of 6" on the edge & 12" in the field.

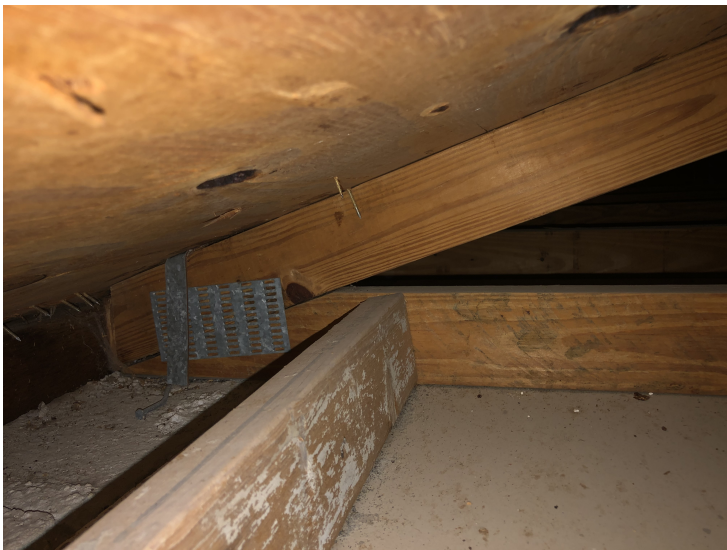
Roof Construction

- 4. Roof to Wall Attachment:** **Toe Nails**
Comments: Inspection verified embedded straps fastened with less than three nails.
- 5. Roof Geometry:** **Flat Roof**
Comments: The roof shape is made up of a combination of flat and pitched sections. The flat section of the roof account for greater than 10% of the total roof perimeter.
