COMMERCIAL WINDSTORM MITIGATION INSPECTION REPORT (OIR-B1-1802)

Banana Bay Condominium

200 S Banana River Blvd, Building 100, Units 101-104
Cocoa Beach, FL 32931

As of 5/20/2022

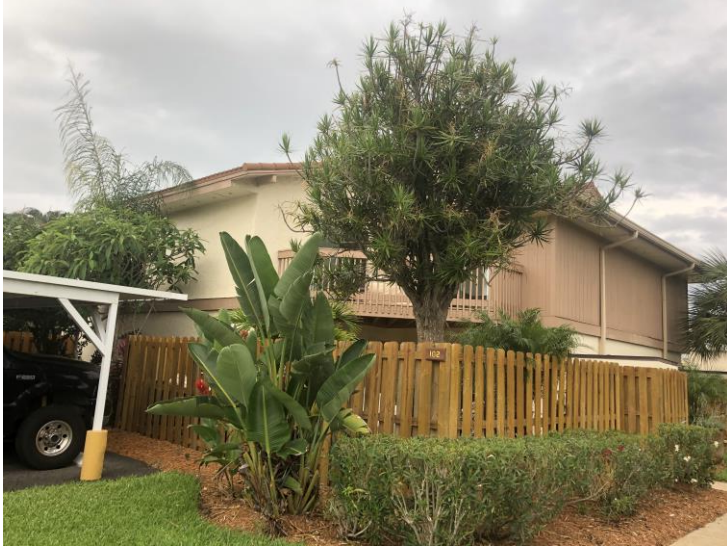
Exterior Elevation

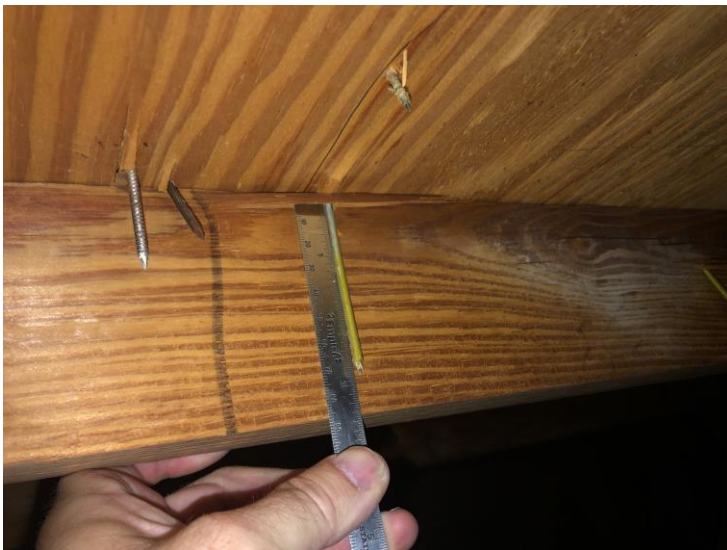
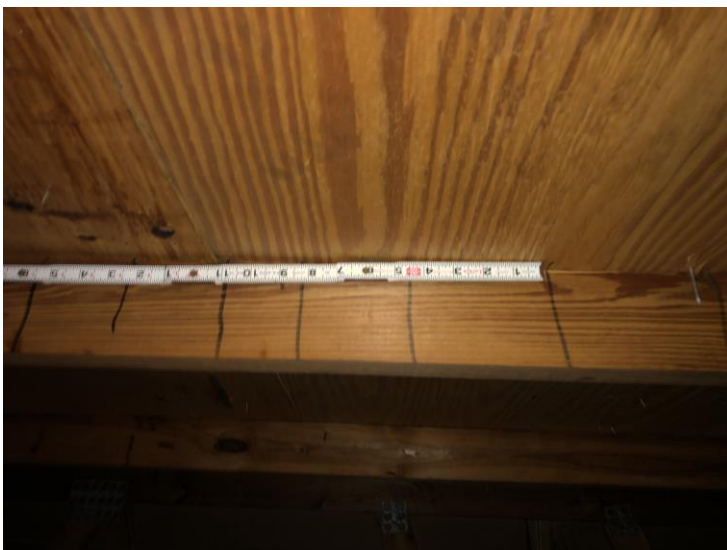
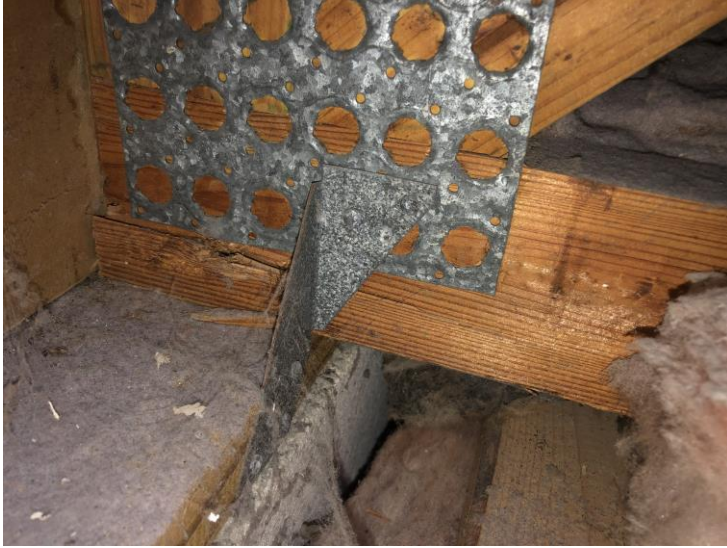
- 3. Roof Deck Attachment:** **Level C**
Comments: Inspection verified 1/2" plywood roof deck attached with 8d nails at a minimum 6" on the edge & 6" in the field.

- 4. Roof to Wall Attachment:** **Clips**
Comments: Inspection verified hurricane clips fastened with a minimum of three nails.
- 5. Roof Geometry:** **Other Roof**
Comments: Inspection verified hip and gable roof shapes. The gable sections of the roof account for greater than 10% of the total roof perimeter.

Roof Construction
