Uniform Mitigation Verification Inspection Form

Inspection Date: 11/19/2018		
Owner Information		
Owner Name: Bayside Condominium Association		Contact Person:
Address: 742 Bayside Dr		Home Phone:
City: Cape Canaveral	Zip: 32920	Work Phone:
County: Brevard		Cell Phone:
Insurance Company:		Policy #:
Year of Home: 2005	# of Stories: 5	Email:

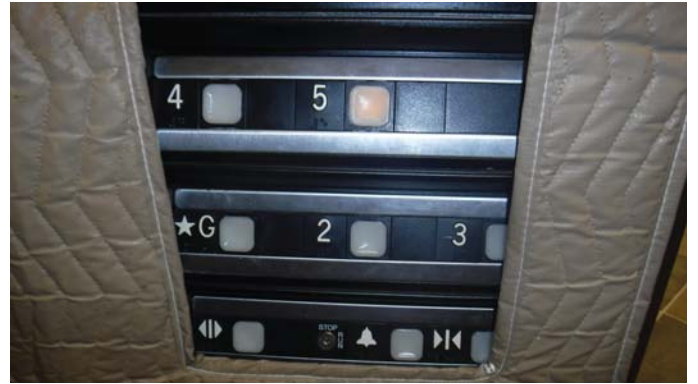
5 Story building

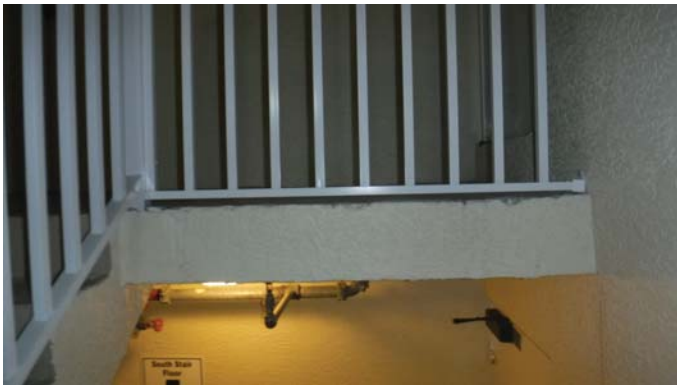
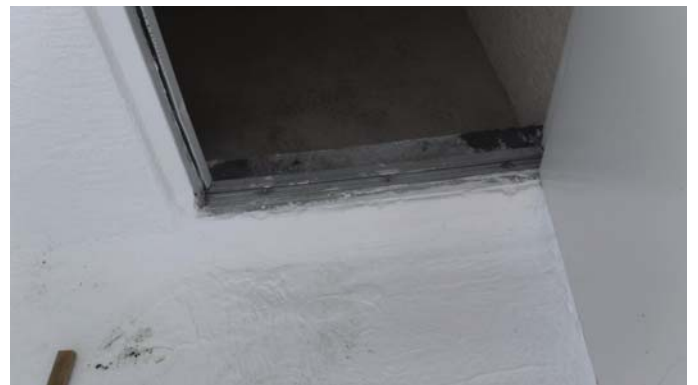
- D. Reinforced Concrete Roof Deck.
- E. Other: _____
- F. Unknown or unidentified.
- G. No attic access.

Concrete roof decking

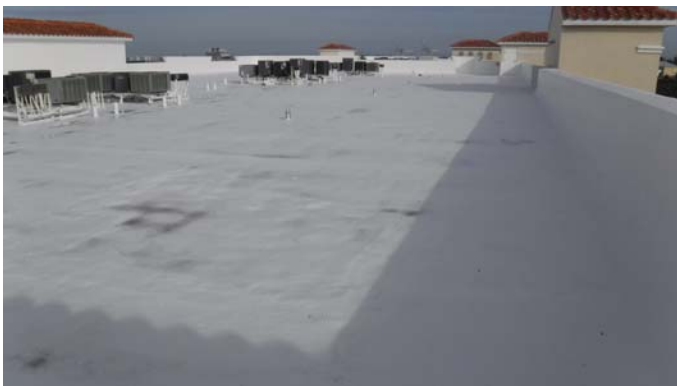
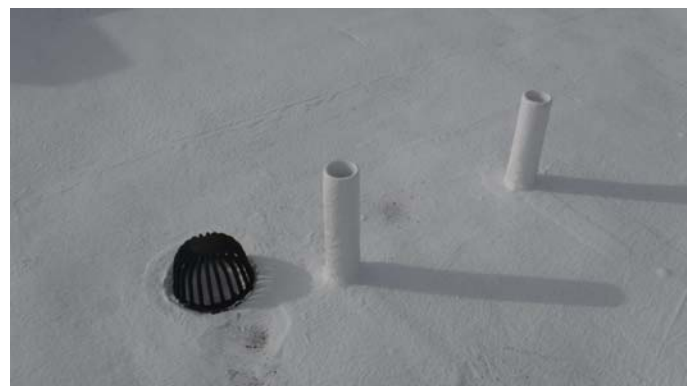
Roof overview

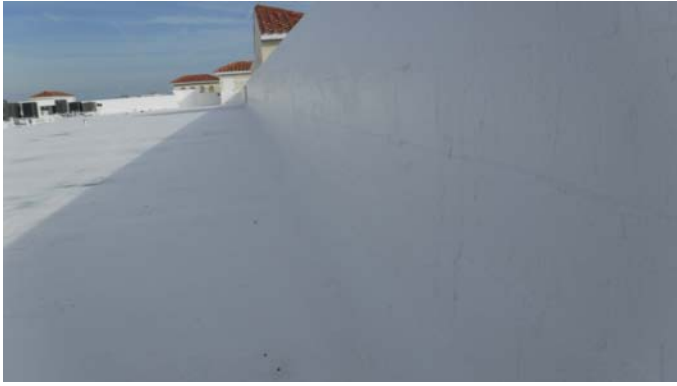
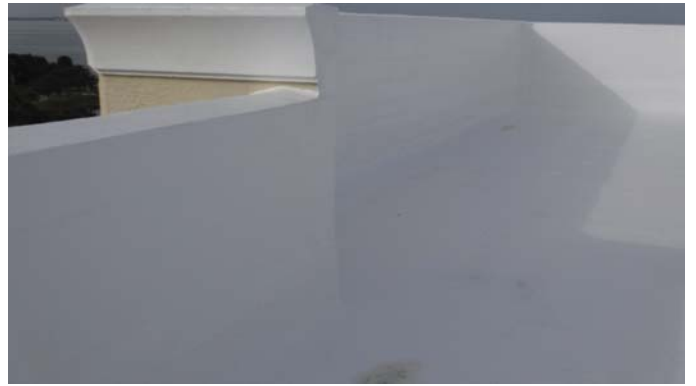
Metal connectors consisting of a single strap that wraps over the top of the truss/rafter and is secured with a minimum of 2 nails on the front side and a minimum of 1 nail on the opposing side.
- D. Double Wraps
 - Metal Connectors consisting of 2 separate straps that are attached to the wall frame, or embedded in the bond beam, on either side of the truss/rafter where each strap wraps over the top of the truss/rafter and is secured with a minimum of 2 nails on the front side, and a minimum of 1 nail on the opposing side, **or**
 - Metal connectors consisting of a single strap that wraps over the top of the truss/rafter, is secured to the wall on both sides, and is secured to the top plate with a minimum of three nails on each side.
- E. Structural Anchor bolts structurally connected or reinforced concrete roof.
- F. Other: _____
- G. Unknown or unidentified
- H. No attic access

Structurally attached

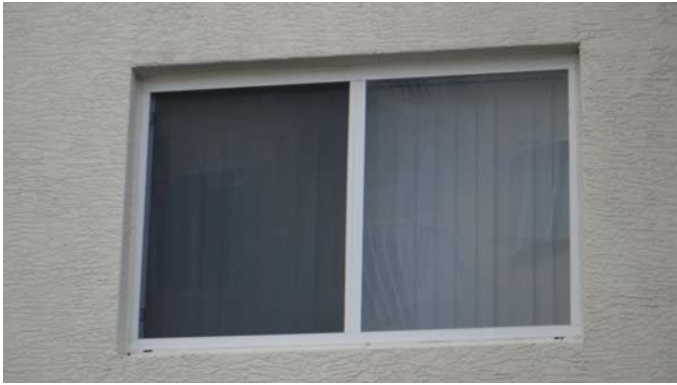
- N. Exterior Opening Protection (unverified shutter systems with no documentation)** All Glazed openings are protected with protective coverings not meeting the requirements of Answer "A", "B", or "C" or systems that appear to meet Answer "A" or "B" with no documentation of compliance (Level N in the table above).
- N.1 All Non-Glazed openings classified as Level A, B, C, or N in the table above, or no Non-Glazed openings exist
- N.2 One or More Non-Glazed openings classified as Level D in the table above, and no Non-Glazed openings classified as Level X in the table above
- N.3 One or More Non-Glazed openings is classified as Level X in the table above
- X. None or Some Glazed Openings** One or more Glazed openings classified and Level X in the table above.

Glazed opening - not protected

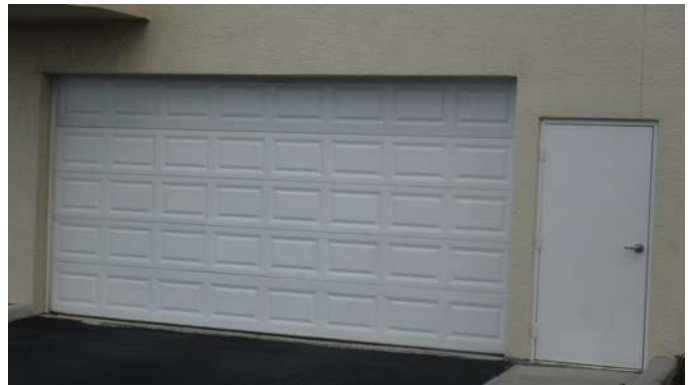
Non-glazed opening - not rated
