Maintain a copy of this form and any documentation provided with the insurance policy

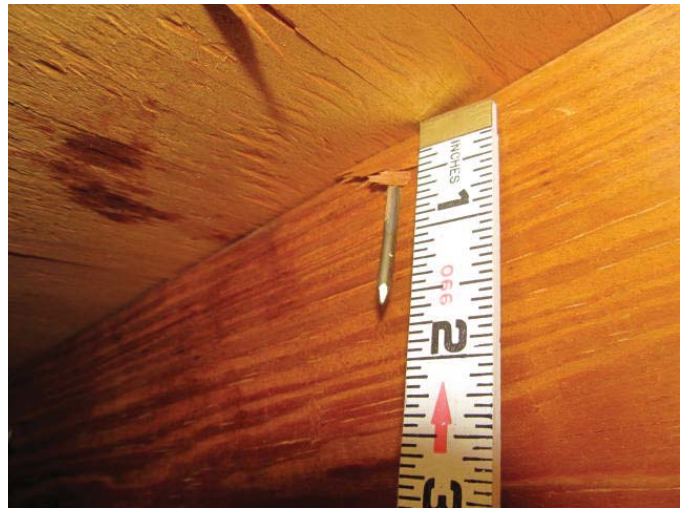
- A. Plywood/Oriented strand board (OSB) roof sheathing attached to the roof truss/rafter (spaced a maximum of 24" inches o.c.) by staples or 6d nails spaced at 6" along the edge and 12" in the field. -OR- Batten decking supporting wood shakes or wood shingles. -OR- Any system of screws, nails, adhesives, other deck fastening system or truss/rafter spacing that has an equivalent mean uplift less than that required for Options B or C below.

6D nails

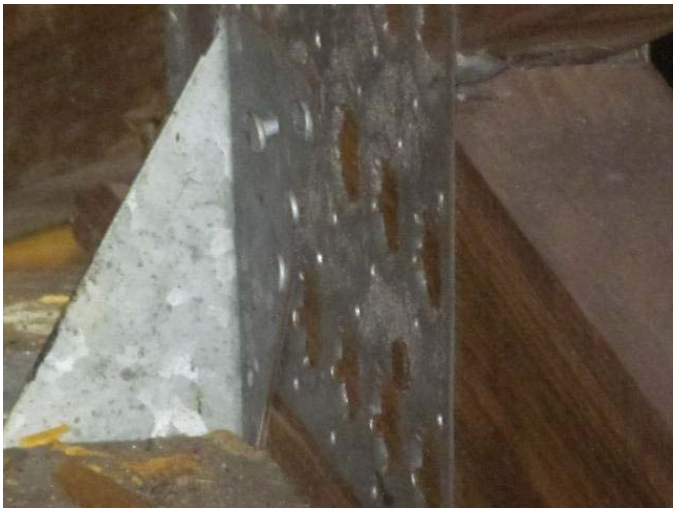
- B. Clips
 - Metal connectors that do not wrap over the top of the truss/rafter, **or**
 - Metal connectors with a minimum of 1 strap that wraps over the top of the truss/rafter and does not meet the nail position requirements of C or D, but is secured with a minimum of 3 nails.
- C. Single Wraps

Clips - with minimum three nails
