Uniform Mitigation Verification Inspection Form

Inspection Date: 03/20/2023		
Owner Information		
Owner Name: Whitley Bay Condominium Association Inc		Contact Person:
Address: 93 Delannoy Ave		Home Phone:
City: Cocoa	Zip: 32922	Work Phone:
County: Brevard		Cell Phone:
Insurance Company:		Policy #:
Year of Home: 2004	# of Stories: 13	Email:

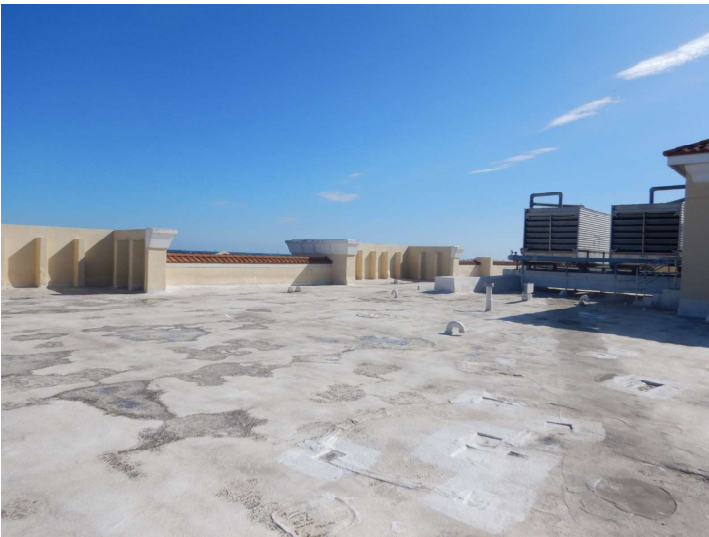
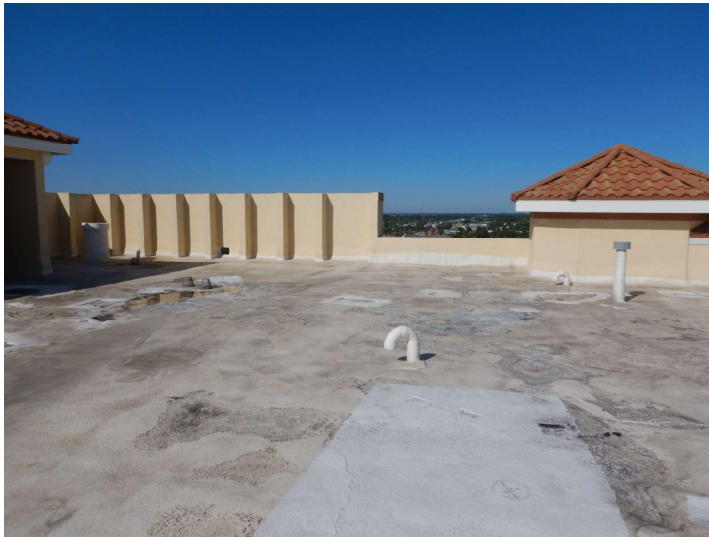
- ☐ A. Hip Roof Hip roof with no other roof shapes greater than 10% of the total roof system perimeter.
Total length of non-hip features: _____ feet; Total roof system perimeter: _____ feet
- ☒ B. Flat Roof Roof on a building with 5 or more units where at least 90% of the main roof area has a roof slope of less than 2:12. Roof area with slope less than 2:12 _____ sq ft; Total roof area _____ sq ft
- ☐ C. Other Roof Any roof that does not qualify as either (A) or (B) above.

Roof overview

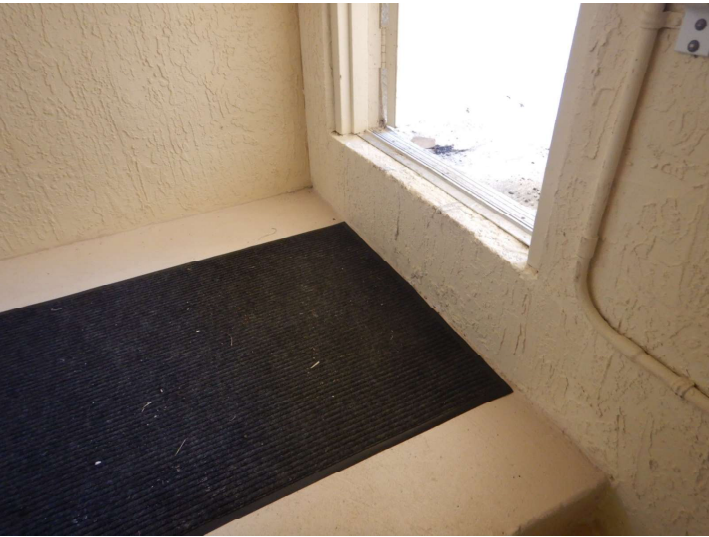
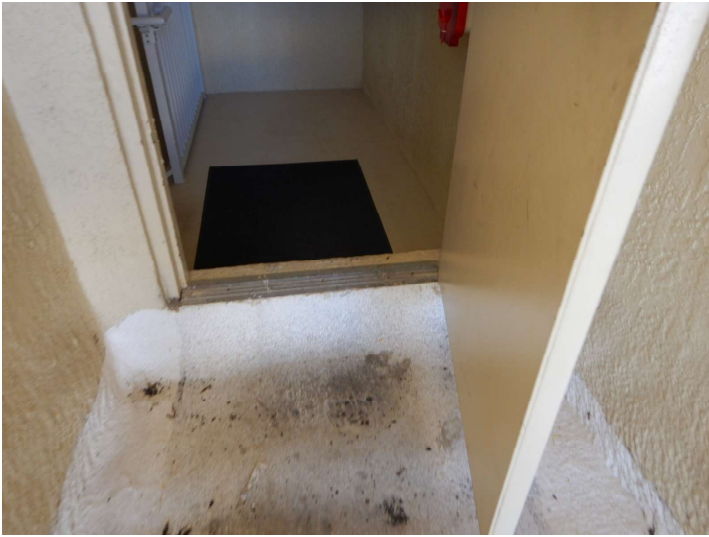
- ☒ D. Reinforced Concrete Roof Deck.
- ☐ E. Other: _____
- ☐ F. Unknown or unidentified.
- ☐ G. No attic access.

Reinforced Concrete Roof Deck.

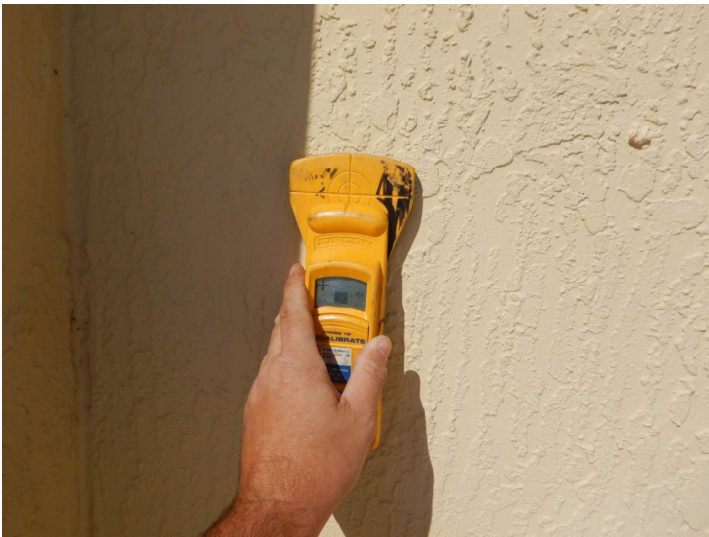
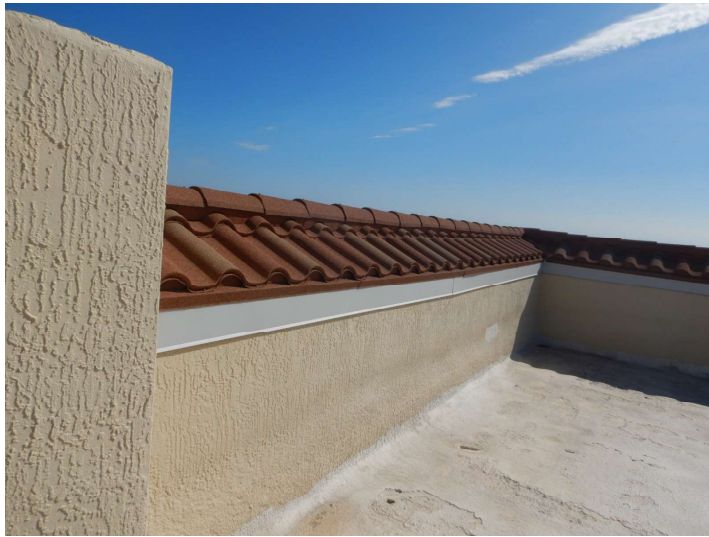
- ☒ E. Structural Anchor bolts structurally connected or reinforced concrete roof.
- ☐ F. Other: _____
- ☐ G. Unknown or unidentified
- ☐ H. No attic access

Structural
