**OCEAN PARK
OWNERS' ASSOCIATION, INC.
FULL RESERVE STUDY REPORT**

For 30-Year Projection Period: FY 2023 through FY 2053

Reference #: 1048.23

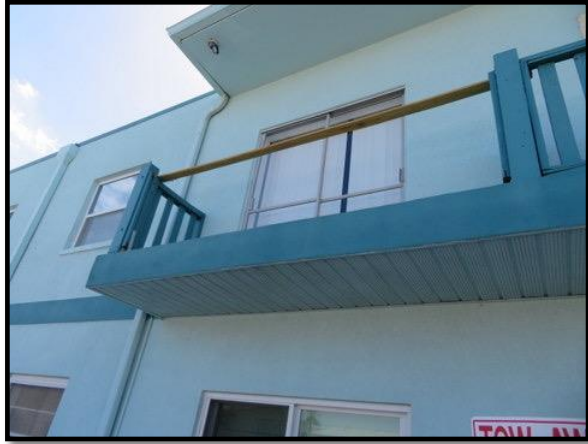
The Association is responsible for 24 balconies that range in size. Ocean Park South is currently in the process of replacing balconies and has replaced seven to date. The railings and ceilings of the new balconies comprise concrete and have a long useful life with the benefit of periodic maintenance. The Association should continue to plan for phased replacements of up to two balconies until 2030. Waterproof coatings are included in Line Item 10.

Figure 1 – Original Balcony

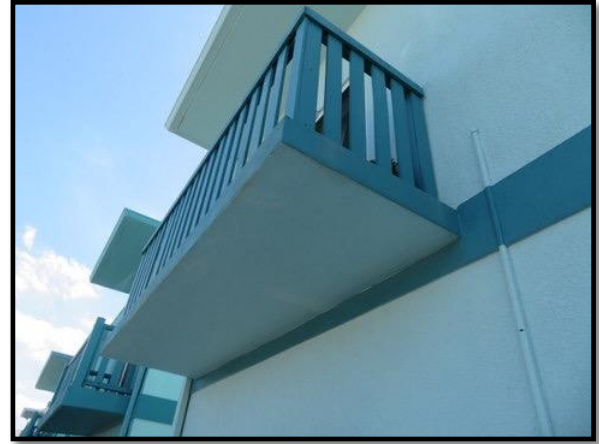
Figure 2 – Replaced Balcony

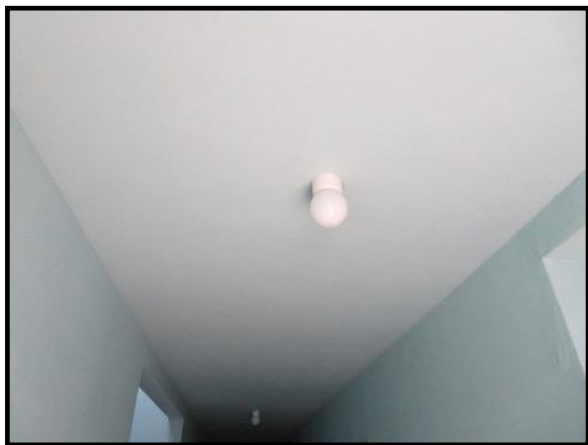
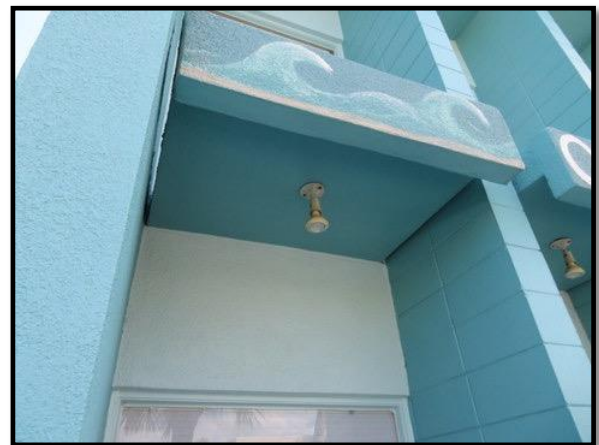
The Association maintains 138 exterior ceiling mounted light fixtures. The light fixtures are in fair condition at an age of 12 years. Light fixtures of this type have a useful life of up to 20 years.

Ocean Park South should budget for replacement of the light fixtures by 2031 and again by 2051. The Association should consider replacements with light emitting diode (LED) technology.

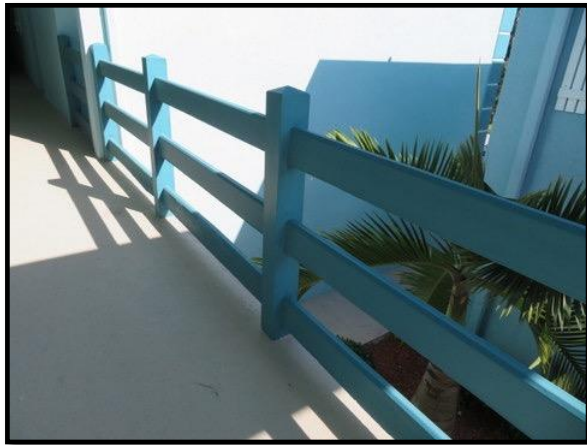
The Association maintains approximately 1,560 linear feet of a combination of wood and Kynar railings. The railings are in fair overall condition at various ages. The major concern with railings is safety. Kynar railings have a useful life of up to 30 years. Ocean Park South should budget for phased replacements of up to seventeen percent (16.7%) beginning in 2024 and every five years thereafter. The finish on aluminum fences is relatively maintenance free.

Figure 1 – Breezeway Railing

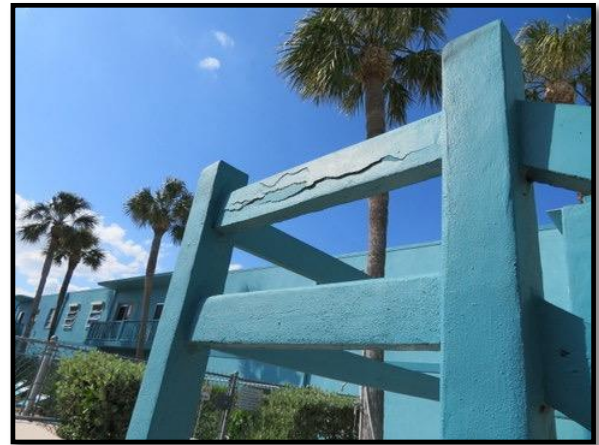
Figure 2 – Railing Cracks

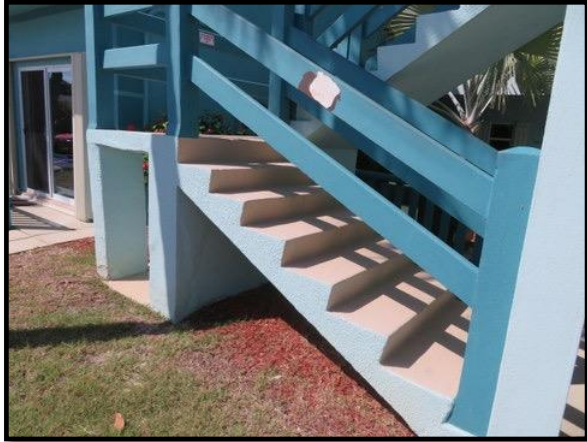
Concrete is strong in compression and weak in tension and therefore requires steel reinforcing. Concrete corrosion is caused by rainwater and chlorides (salt) getting into the concrete down to the level of the steel. Concrete cracks and spalling occur from the expansion of the reinforcing steel due to corrosion. Once the corrosion process has been initiated, the Association should budget for partial repairs as needed in 2024 and every 5- to 10-years thereafter in conjunction with paint finish applications.

Figure 1 – Staircase Railings Spall

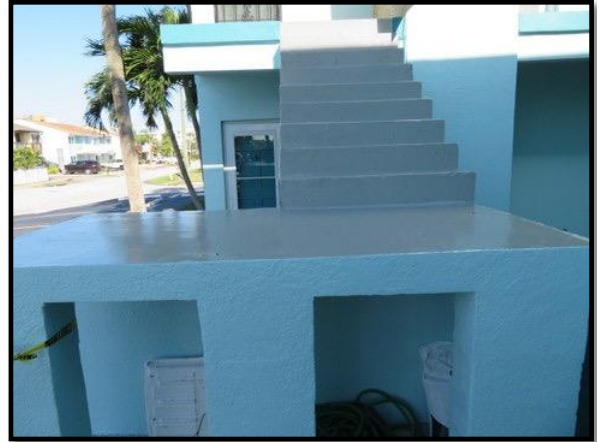
Figure 2 – New Staircase

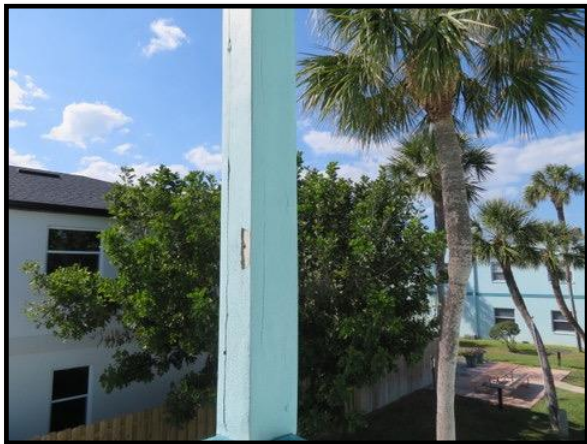
Figure 1 – Beam Spall

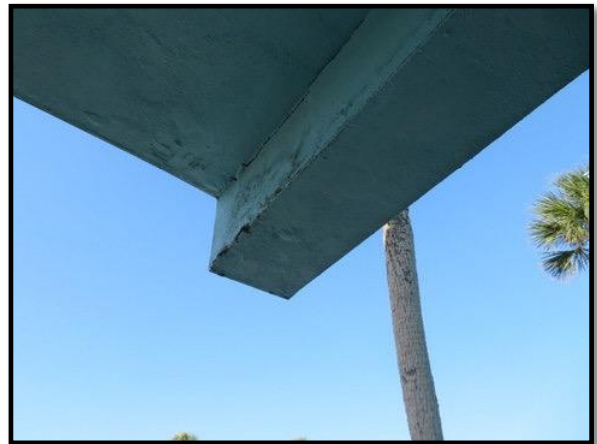
Figure 2 – Beam Crack

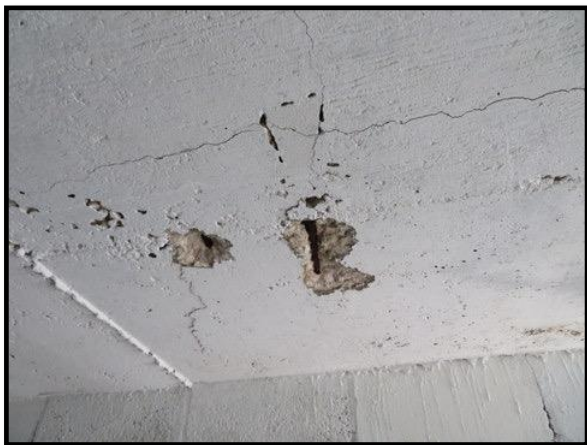
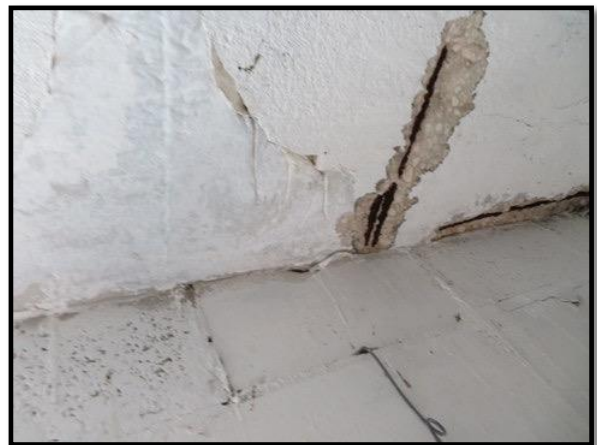
Figure 3 – Pool Equipment Spall

Figure 4 – Pool Equipment Spall

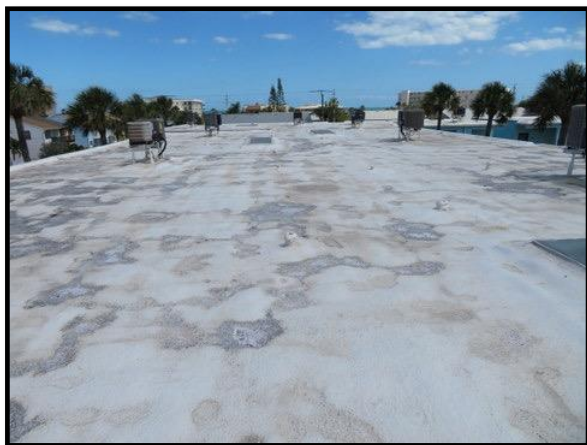
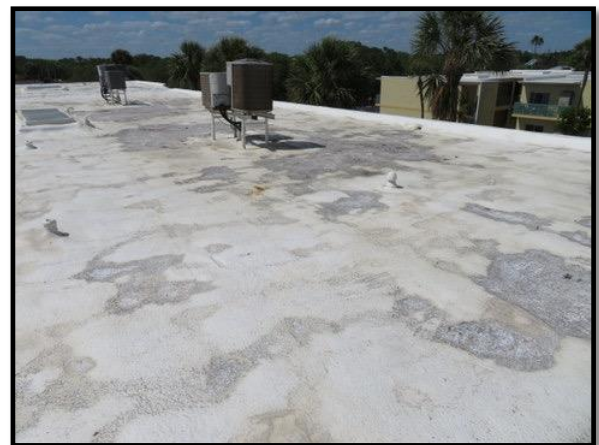
The Association is responsible for the roofing which utilizes spray polyurethane foam (SPF). SPF roofing is applied as a liquid atop the existing substrate. As such it has the ability to bridge small cracks and potential sources of water infiltration through the pre-existing roof substrate. The initial foam layer is then topped with one or multiple layers of elastomeric silicone or an acrylic coating containing slip-resistant granules. When properly installed the benefits of an SPF roof may include better penetration protection due to its thickness, better waterproofing properties due to the nature of its seamless installation, improved building insulation and therefore reduced energy consumption costs, and adherence to fire rating code requirements.

Figure 1 – E Section

Figure 2 – G Section

Based on the poor overall condition of the SPF roofs, the Association plan for a removal and recoating replacement in 2024 and again by 2048. An interim coating is likely by 2036.

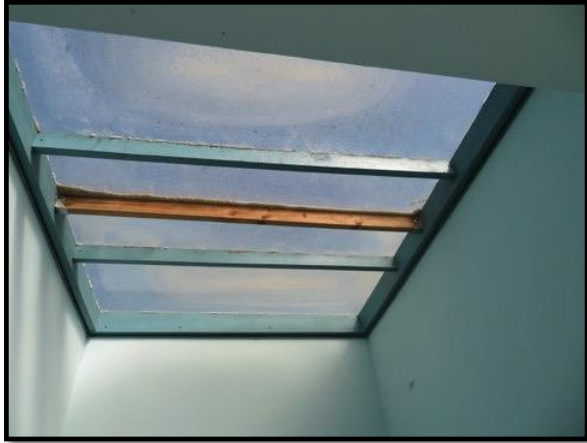
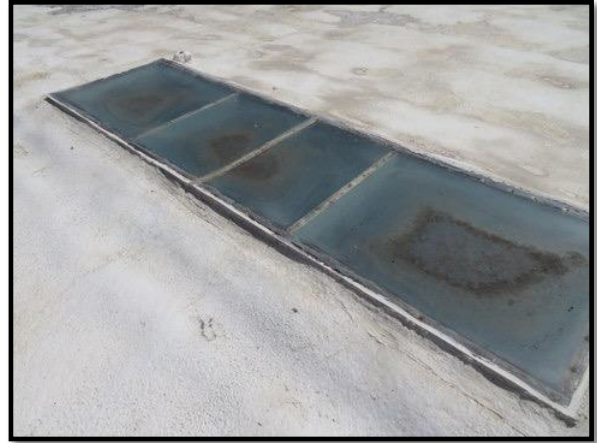
The Association maintains 15 skylights of varying sizes. The skylights are in poor condition overall at an approximate age of seven years reportedly. The Board reports that Ocean Park South plans to replace the skylights in conjunction with the roof. New skylights have an estimated useful life of up to 25 years. Ocean Park South should budget for subsequent replacements by 2048.

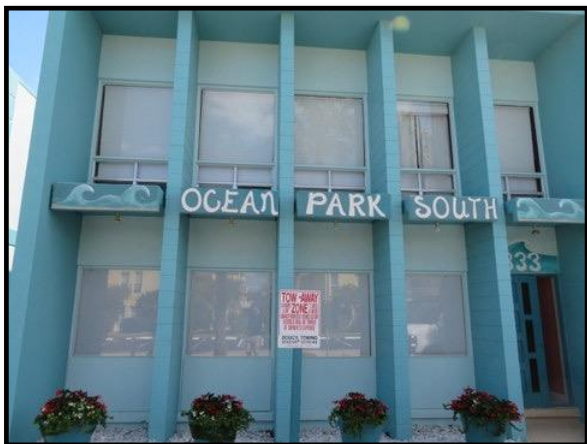
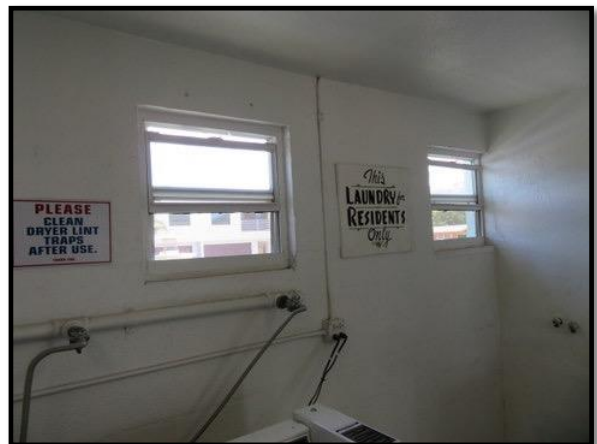
The common windows comprise 105 square feet. The windows are likely original and in fair overall condition. Windows have a useful life of up to 45 years. Ocean Park South should budget for replacement of the windows with white fiberglass in 2024. The windows should meet the Florida Building Code for impact resistance.

Figure 1 – Office Windows

Figure 2 – Laundry Room Windows

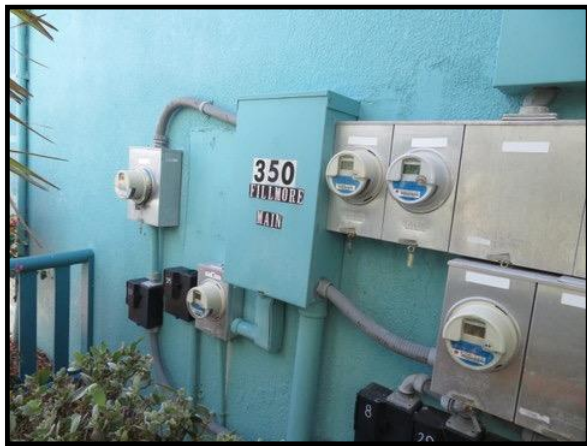
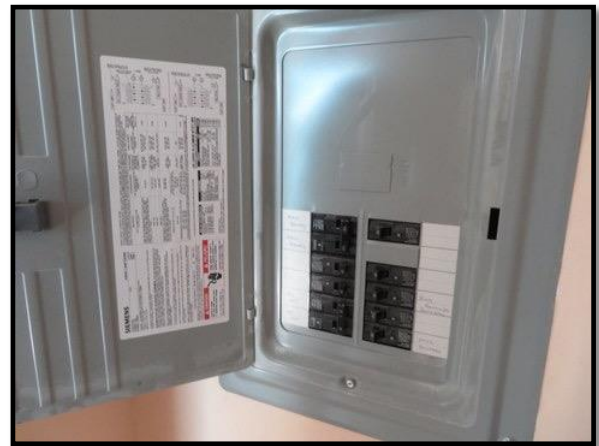
The common area main electrical panels are in satisfactory operational condition. The useful life of these components is up to and often beyond 75 years. However, not all components will fail simultaneously. The Board reports that Ocean Park South replaced three panels. The Association should budget for partial replacement of the electrical systems beginning by 2033 and every 10 years thereafter.

Figure 1 – Main Electric Panel

Figure 2 – Office Electric Panel

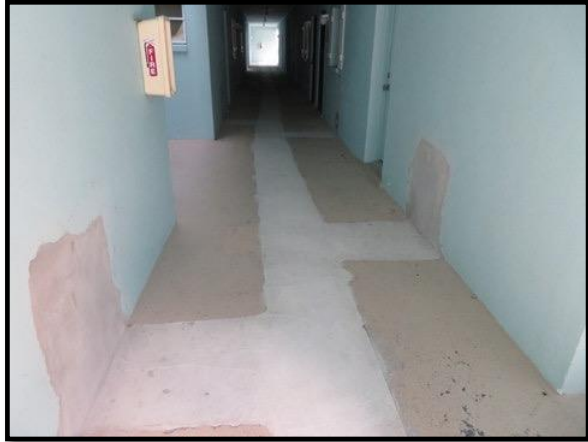
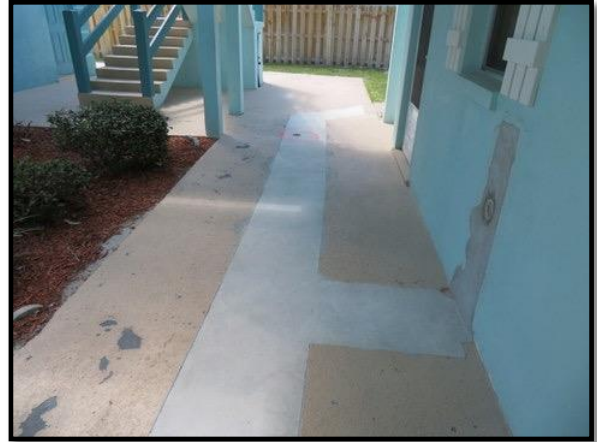
The common plumbing systems are reported in fair to poor overall condition. Previous repairs are noted. The Association should anticipate periodic repairs as needed and inspect the plumbing system annually. Ocean Park South should budget for partial plumbing system renovations as depicted in **Appendix A**. The following table depicts what has been done and what is anticipated to be done in the near term.

Figure 1 – Previous Repairs Building E

Figure 2 - Previous Repairs Building E

The Association may find value in the use of in-place pipe restoration technology such as pipe relining. In-place pipe restoration technology involves camera-scoping, cleaning, and preparing of the pipe interiors followed by installation of a pressurized liquid epoxy which hardens to become structural in nature. This can be a more efficient and cost-effective option in that the need for opening wall cavities in both common areas and unit interiors can be greatly minimized. Pipe lining causes the least amount of disruption to the unit owners.

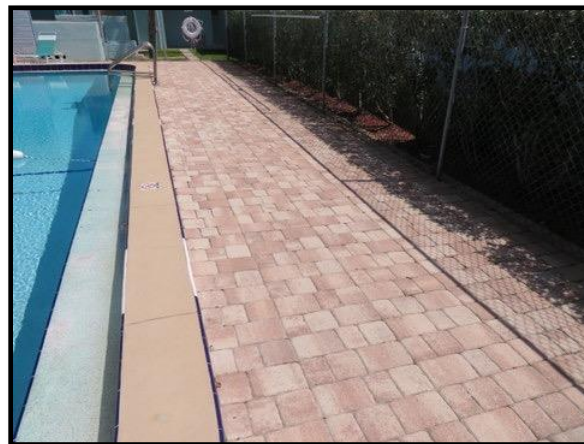
Figure 1

The pool deck comprises 2,045 square feet of pavers. This quantity includes the siting area. The pavers are in good overall condition at varying ages. Pool deck pavers have a useful life from 20- to 30-years with the benefit of periodic maintenance. Periodic maintenance includes resetting as needed and an application of sand between the pavers followed by a sealer application every three years. Ocean Park South should budget for replacement of the pavers by 2034. Interim repairs should be funded through the operating budget as needed.

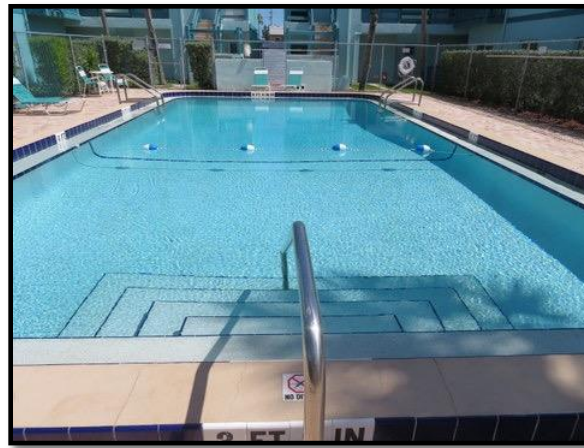
Figure 1

The Association maintains approximately 945 square feet of horizontal pool finish. The pool finish is in fair to good condition at an age of six years. The pool finish has a useful life from 10- to 15-years. Ocean Park South should budget for resurfacing of the pool finish by 2032 and again by 2047. Typically, minor upgrades will be needed to bring the pool up to current code. An allowance for replacement of the waterline tile is included in the estimate of cost. Potential repairs to the underlying pool structure may raise the estimate of cost.

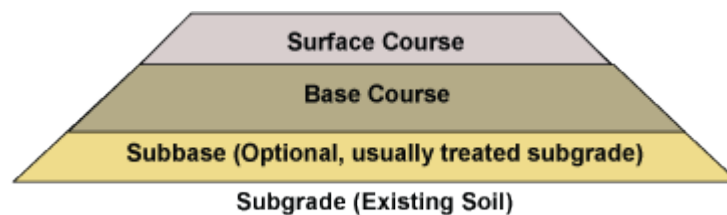
The Association maintains approximately 3,190 square yards of asphalt streets and parking areas. The asphalt pavement is original and in fair overall condition. Asphalt pavement comprises multiple layers. Typically, the top layer or surface course deteriorates over time and can be milled or removed and overlaid or replaced. The following diagram depicts typical pavement layers.

A mill and overlay is a method of repaving of the surface course where cracked, worn and failed pavement is mechanically removed or milled. A new layer of asphalt is overlaid atop the remaining sound pavement. Milled pavement removes part of the existing pavement and permits the overlay to match the elevation of areas such as adjacent catch basins, curbs and gutters. The milled pavement should be properly bonded to the new overlayment. Overlayment thicknesses range from one to two inches. Variable thicknesses are often necessary for proper drainage.

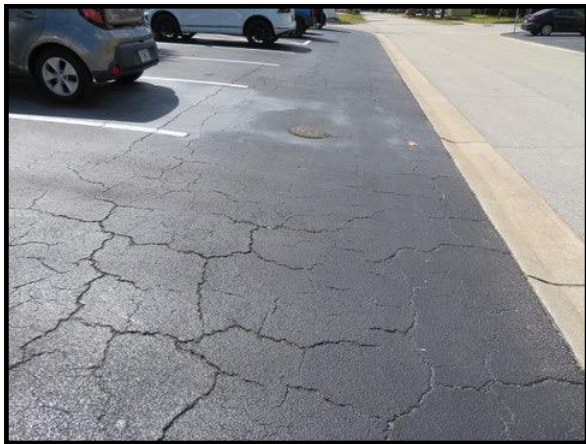
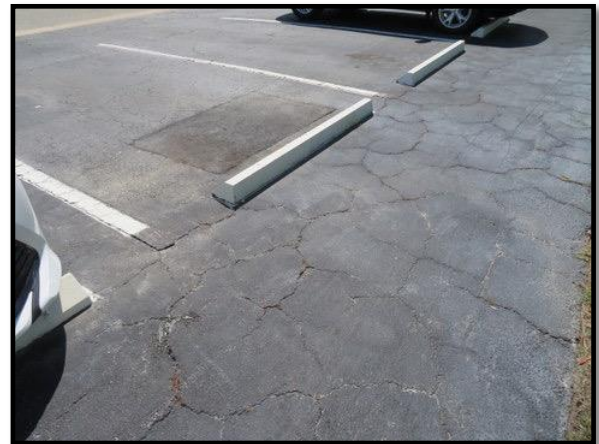
Figure 1 – Significant Cracks

Figure 2 - Significant Cracks

A combination of area patching, crack repair and milling should occur before the overlayment. Areas that exhibit potholes, alligator cracks and areas of pavement that are deteriorated from vehicle fluids should all be repaired prior to overlayment. Area patching may require total replacement of isolated areas of pavement. The base course for residential subdivision roadways designed for light traffic is often six inches thick. The paving contractor should seal all cracks. Crack repair minimizes the chance of underlying cracks coming through the overlayment.

The useful life of the asphalt pavement surface course is from 15- to 25-years. Ocean Park South should budget for a mill and overlay of the pavement by 2028. The Association should retain an engineer for quality control.

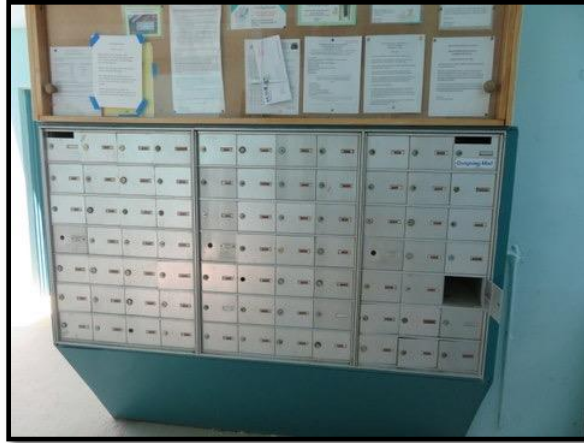
Figure 1

Ocean Park South maintains the mailboxes for each resident. The mailboxes are in fair overall condition at an unknown age. Metal mailboxes have a useful life of up to 25 years. The Association should budget for replacements in 2024. The Association should verify new mailboxes meet the specifications of the United States Postal Service.
