"Full" Reserve Study

Whitley Bay Condominiums Cocoa, FL

Report #: 36044-0
For Period Beginning: January 1, 2020
Expires: December 31, 2020

Date Prepared: May 6, 2019

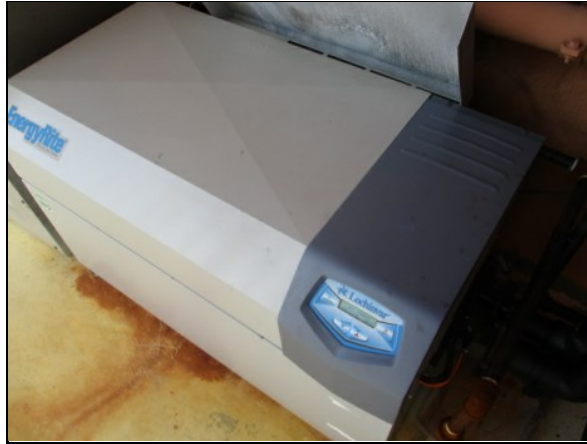
Comp #: 2781 Spa Heater - Replace

History: Per information provided, heater replaced in 2017 for approx \$7,000

Pool vendor should inspect heater regularly to ensure proper function, identify any required repairs, etc. Internal components were not analyzed during our site inspection. Many clients choose not to heat their pools year-round, which can prolong the life of the heater while reducing energy costs. When replacement models are being evaluated, we recommend considering high efficiency models which may have a higher initial cost but will ultimately be less expensive due to reduced energy usage. Minimal or no subjective/aesthetic value for pool and spa equipment. Useful life is based primarily on normal expectations for service/performance life in this location. Unless otherwise noted, remaining useful life expectancy is based primarily on original installation or last replacement/purchase date, our experience with similar systems/components, and assuming normal amount of usage and good preventive maintenance.

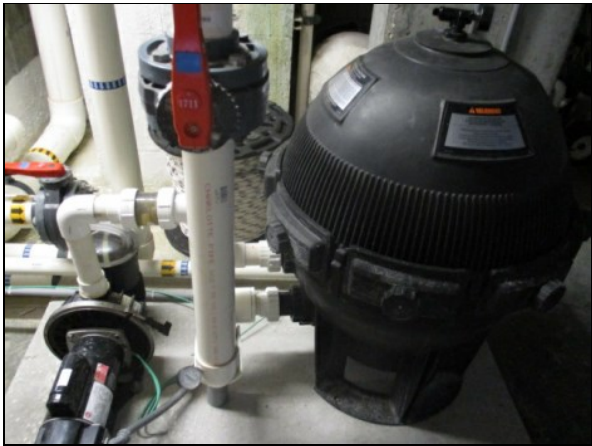
Comp #: 2783 Pool/Spa Pumps - Repair/Replace

Comments: In general, costs related to this component are expected to be included in the Client's Operating budget. No recommendation for Reserve funding at this time. However, any repair and maintenance or other related expenditures should be tracked, and this component should be re-evaluated during future Reserve Study updates based on most recent information and data available at that time. If deemed appropriate for Reserve funding, component can be included in the funding plan at that time.

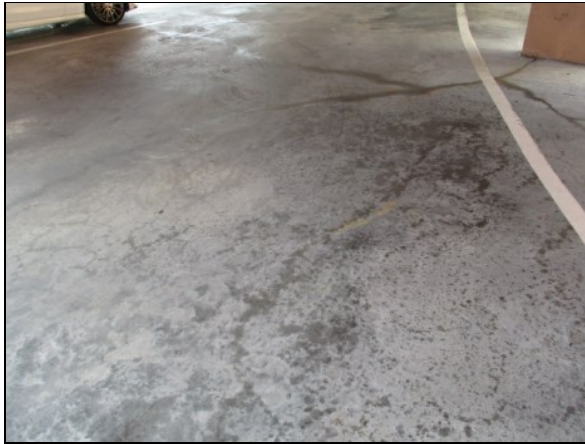
Comp #: 2105 Driveway Concrete - Repair

Comments: Fair condition: Concrete driveways determined to be in fair condition typically may exhibit small changes in slope and narrow "hair-line" wide cracks. Overall, no unusual or extreme signs of age noted. Costs shown below are an ongoing allowance for partial repairs/replacements of only 5% of the total quantity (ie. 900 GSF of 18,000 GSF).

Driveways are reported to be the maintenance and repair responsibility of the Client. Although complete replacement of all areas together should not be required, conditions observed merit inclusion of an allowance for ongoing repairs and partial replacements. Timeline and cost ranges shown here should be re-evaluated during future Reserve Study updates.

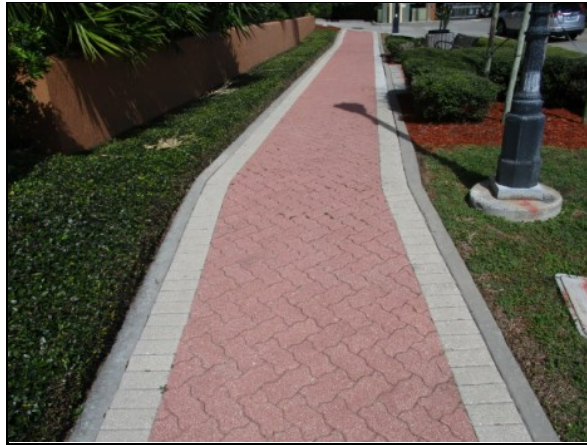
Comp #: 2120 Pavers (Walks/Paths) - Replace

Comments: Fair condition: Paver walkway and/or paths determined to be in fair condition typically exhibit some amount of minor displacement, lifting and tripping hazards, most often in high-traffic areas. Signs of wear and age are evident, but not advanced. Overall appear to be aging normally.

Concrete pavers in sidewalk/path applications should have a very long useful life and typically are replaced for aesthetic reasons before physical failure. Should be inspected regularly for trip hazards, lifting, etc. to avoid liability issues. Individual sections can usually be removed and replaced to address settling issues, lifting from tree roots, cracked pavers, etc. A wide variety of sizes, color patterns and other design choices are available. Cost estimates shown here are based on replacement to a similar standard as existing pavers.

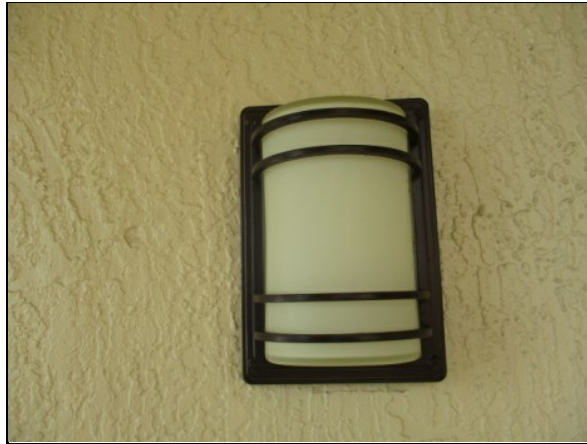
Comp #: 2303 Ext. Lights (Decorative) - Replace

History: Per information provided, balcony lights replaced in 2018 for approx \$9,000

Comments: Good condition: Exterior lights determined to be in good condition typically exhibit only minor signs of normal wear and tear, and are consistent with local aesthetic standards for the development.

Observed during daylight hours, but assumed to be in functional operating condition. As routine maintenance, clean by wiping down with an appropriate cleaner, change bulbs and repair as needed. Best practice is to plan for replacement of all lighting together at roughly the time frame below for cost efficiency and consistent quality/appearance throughout development. Should be coordinated with exterior painting projects whenever possible. Individual replacements should be considered an Operating expense. If available, an extra supply of replacement fixtures should be kept on-site to allow for prompt replacement.

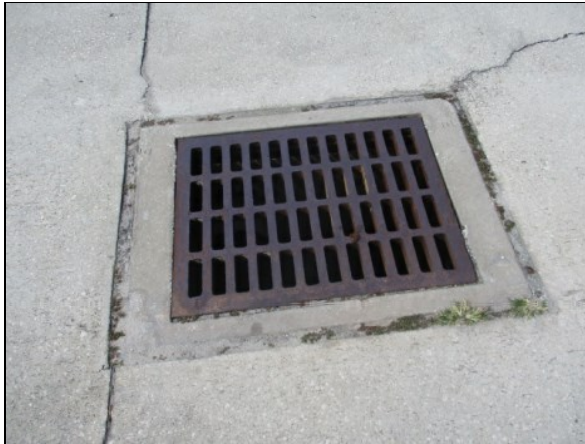
Comp #: 2113 Site Drainage System - Clean/Repair**Quantity: (1) Large System**

Comments: No access to inspect in-ground drainage infrastructure. Annual preventive maintenance work is typically performed as part of a Client's general maintenance/operating fund. Under normal circumstances, site drainage components are constructed of very durable materials which should have a very long useful life (often assumed to be 50 years or more). Repairs may occasionally be required, but timing and scope of work is too unpredictable for Reserve funding in accordance with National Reserve Study Standards. If there are specific, known concerns with drainage system, we recommend further investigation using cameras or other means to document and identify conditions. Some clients consult with civil and/or geotechnical engineers in order to develop scopes of work for repair/replacement. If more comprehensive analysis becomes available, findings should be incorporated into Reserve Study updates as appropriate.

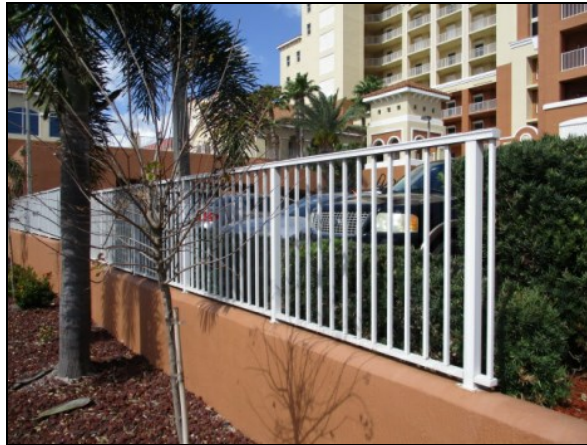
Comp #: 2137 Site Fencing (Metal) - Replace

Comments: Approximately 4' tall, noted in fair condition. Metal fencing determined to be in fair condition typically exhibits some minor to moderate amounts of surface wear and other signs of age, which may include corrosion, loose or unstable pieces/sections or hardware, and/or overgrowth by surrounding vegetation. Overall, appears to be in serviceable but declining condition.

In our experience, metal fencing will typically eventually break down due to a combination of sun and weather exposure, which is sometimes exacerbated by other factors such as irrigation overspray, abuse and lack of preventive maintenance. For some types of fencing, complete replacement is advisable over minor repairs paired with recoating or refinishing due to relatively short lifespan of coatings and consideration of total life-cycle cost.
