THE ASSOCIATION OF PELICAN POINT, INC. STRUCTURAL INTEGRITY RESERVE STUDY

For 30-Year Projection Period: FY 2023 through FY 2053

Reference #: 1120.23

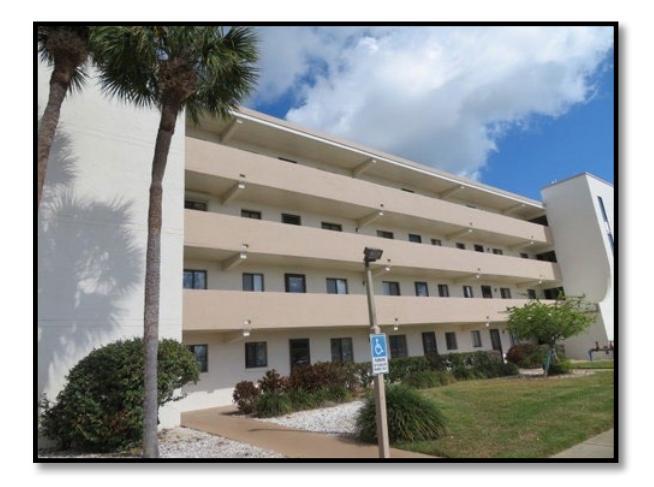
Figure 1 – Typical Front Elevation

Pelican Point maintains breezeways and exposed balconies that comprise approximately 11,835 square feet of concrete surface. The balcony and breezeway coatings are in fair overall condition. Balconies and breezeways have a long useful life with the benefit of periodic maintenance. Concrete cracks and spalling occurs from the expansion of the reinforcing steel bars due to corrosion. Concrete corrosion is caused by rainwater and chlorides penetrating the surface of the concrete and contacting the embedded steel reinforcement bars. Failure to maintain the

balconies and breezeways can lead to costly repairs. The Association should budget for waterproof coating applications and partial repairs as needed in 2024 and every 5- to 10-years thereafter in conjunction with paint finish applications. In addition, Pelican Point should budget for full coating replacement every 15- to 20-years beginning by 2032.

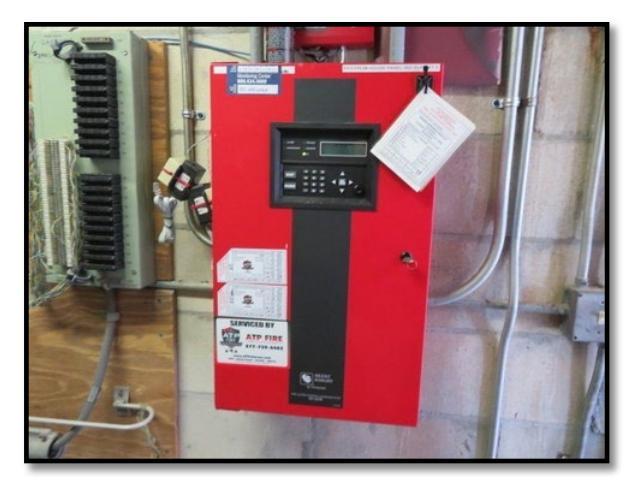
Figure 1 - Building C Control Panel

The Association maintains fire protection systems. A fire protection system comprises a main panel that controls emergency devices such as annunciators and pull boxes. The fire protection systems are in fair operational condition. The exact ages are unknown. Changes in building codes and/or technology may make a replacement necessary and/or desirable prior to the useful life of up to 25 years. Pelican Point should budget for replacements by 2028 and again by 2053. Annual fire alarm system inspections are required by the National Fire Protection Association (NFPA) 722 Standards. The Association should fund interim replacement of exit signs and smoke detectors through the operating budget as needed.

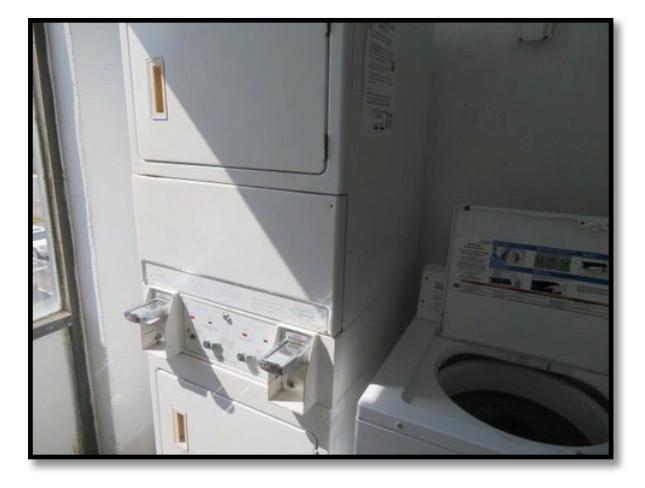
Figure 1 – Building A Washer and Dryers

The Association maintains 48 washers and dryers. The washers and dryers were in satisfactory operational condition at an age of 10 years. Washers and dryers have a useful life of up to 15 years. Pelican Point should budget for replacements by 2028 and again by 2043.

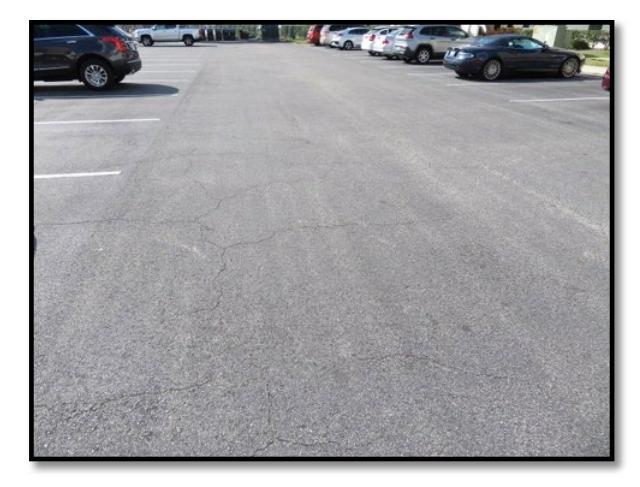
Figure 1

The Association maintains approximately 11,870 square yards of asphalt streets and parking areas. The asphalt pavement is in good overall condition at an age of 11 years. Asphalt pavement comprises multiple layers. Typically the top layer or surface course deteriorates over time and can be milled or removed and overlaid or replaced. The following diagram depicts typical pavement layers.

The useful life of the asphalt pavement surface course is from 15- to 25-years. Pelican Point should budget for a mill and overlay of the pavement by 2037. The Association should retain an engineer for quality control.

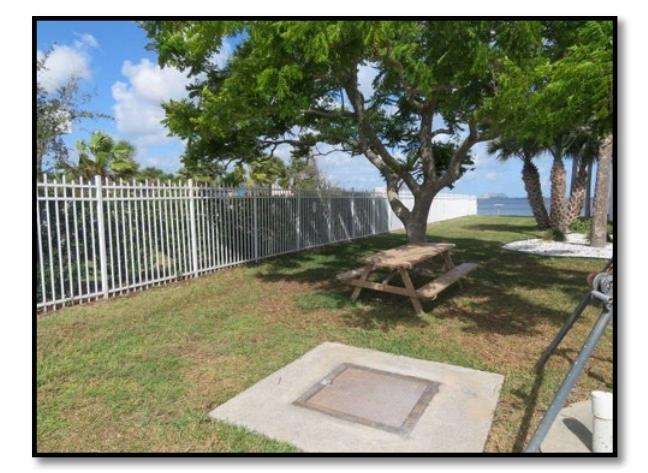
Figure 1

The Association maintains the aluminum fences located along the west perimeter. The fences are in fair overall condition at an age of 18 years. The finish on aluminum fences is relatively

maintenance free. Aluminum fences have a useful life of up to 35 years. The Association can maximize the useful life of the fences by keeping vegetation out of close proximity to the fences as well as repair connections and fasteners promptly when and if they fail. These activities should be funded through the operating budget on an as needed basis. In addition, we recommend the Association budget for replacement of these fences by 2030.

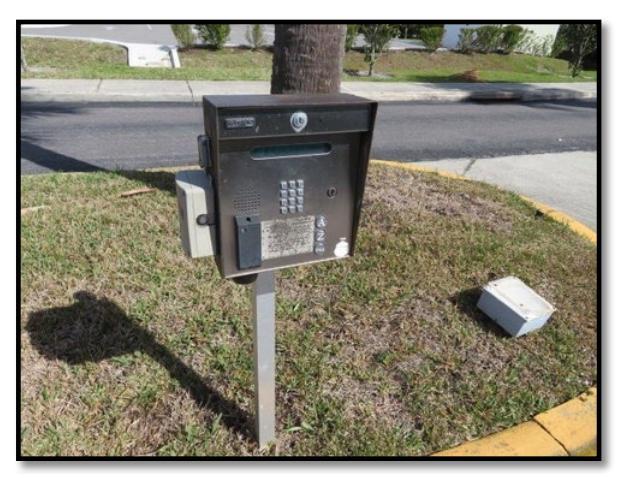
Figure 1 – Telephone Entry System

The Association maintains a gate system that includes two gates and operators and a telephone entry system. The gate system components are in fair condition at ages of up to 18 years. The gate system has a useful life of up to 25 years. Pelican Point should budget for replacement of the gate system by 2030. The Association should fund interim repairs through the operating budget.

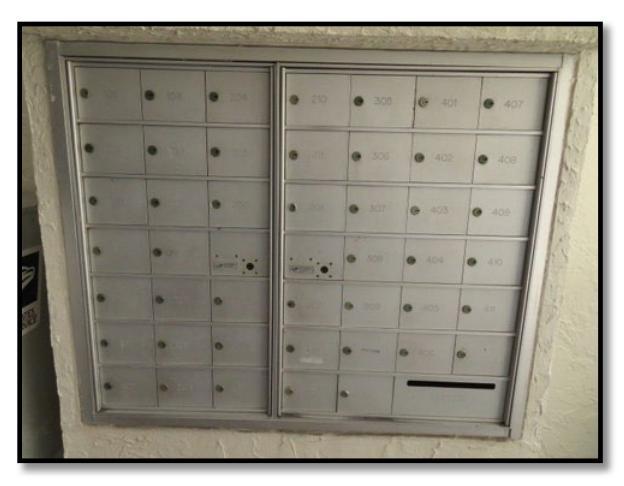
Pelican Point maintains 131 mailboxes. The mailboxes are in fair condition at an age of 19 years. Metal mailboxes have a useful life of up to 20 years. The Association should budget for replacements in 2024 and again by 2044. The Association should verify new mailboxes meet the specifications of the United States Postal Service.

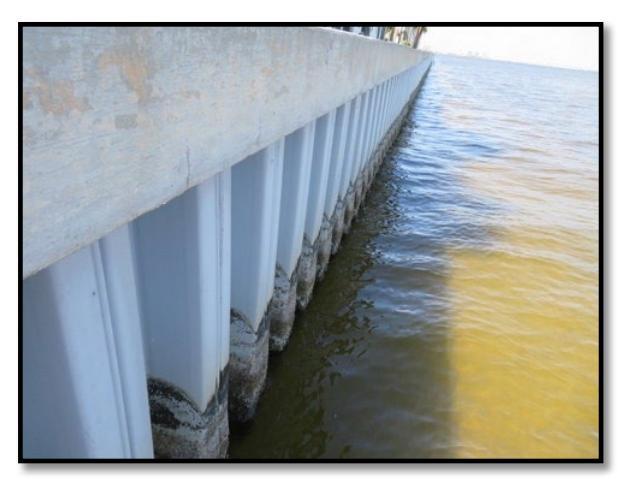
Figure 1

Pelican Point maintains approximately 1,210 linear feet of a vinyl panel sea wall with a concrete cap. The sea wall is in good condition overall at an age of five years. Significant areas of displacement around Building B are noted. Management reports that the Association plans to repair the sea wall through a special assessment. The cap encases the walls anchoring system and transfers the load and is an essential structural component of a sea wall. Sea walls of this type have a long useful life with the benefit of ongoing maintenance. Ongoing maintenance includes power washing and sealing the cap, filling the cracks with epoxy and partial replacements of the concrete as needed. Pelican Point should fund this maintenance activity through the operating budget. The Association should budget for partial replacements of up to seventy percent (70%) of the sea wall by 2053.

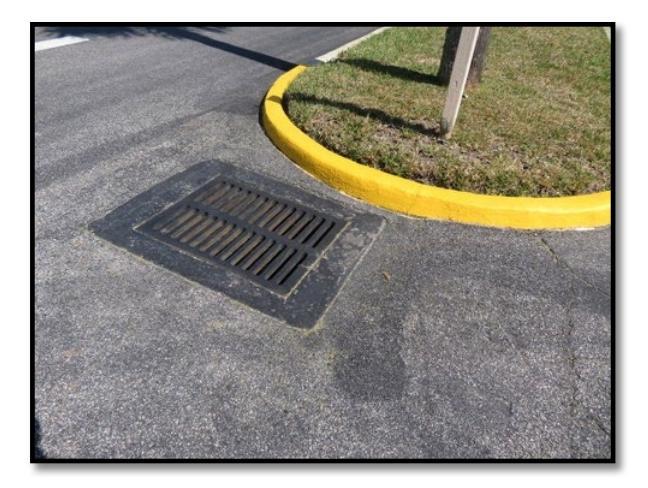
Figure 1 - Catch Basin and Curbing

The overall reported condition of the stormwater structures is good. Stormwater systems have a long useful life with the benefit of ongoing maintenance. Achieving this useful life typically requires interim capital repairs or partial replacements. Maintenance of stormwater systems is required in every municipality as a condition for use of the land to prevent adverse impacts on adjoining properties. Pelican Point should budget for stormwater repairs and or partial replacements by 2037.

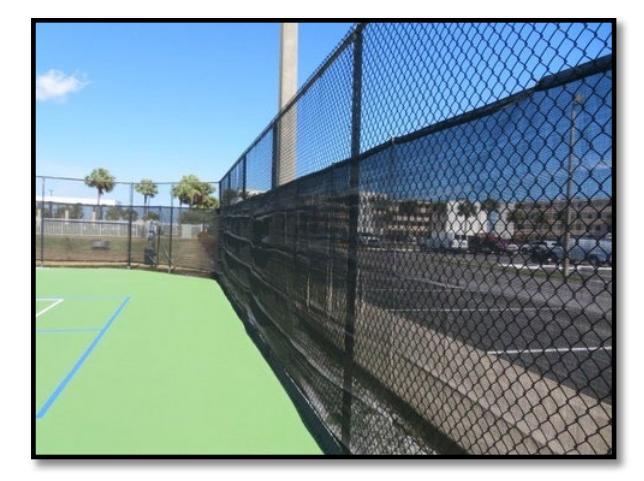
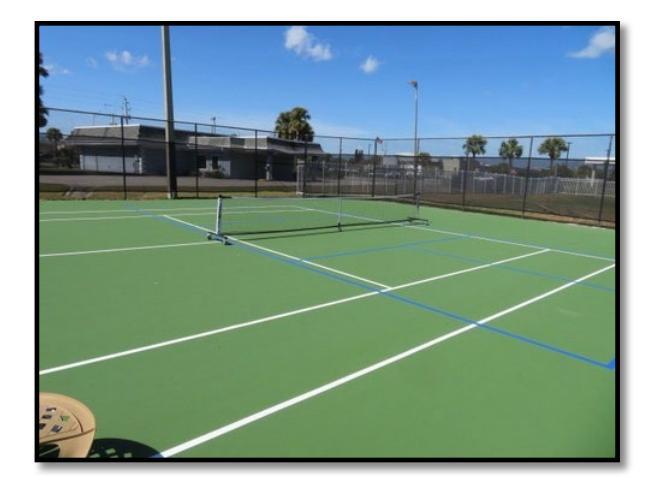
The 360 linear feet of fence that surrounds the tennis court is in fair overall condition at an age of nine years. The fence has a useful life of up to 30 years. Pelican Point should budget for replacement of the tennis court fence by 2044.

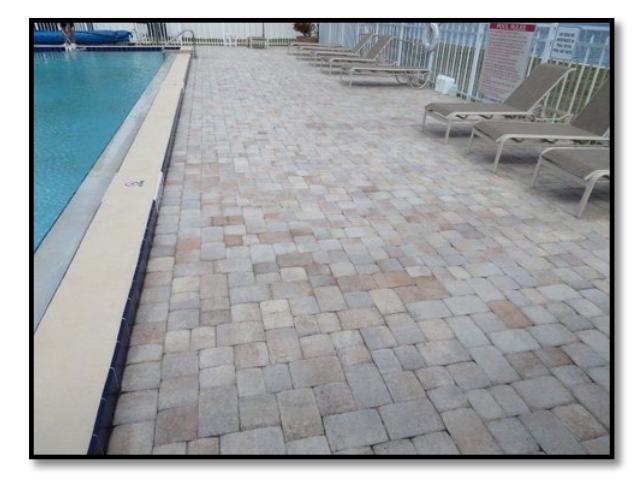
Figure 1 – Paver Deck

The pool deck comprises 4,120 square feet of pavers. The pavers are in good overall condition at an age of seven years. Pool deck pavers have a useful life from 20- to 30-years with the benefit of periodic maintenance. Periodic maintenance includes resetting as needed and an application of sand between the pavers followed by a sealer application every three years. Pelican Point should budget for replacement of the pavers by 2046. Interim repairs should be funded through the operating budget as needed.

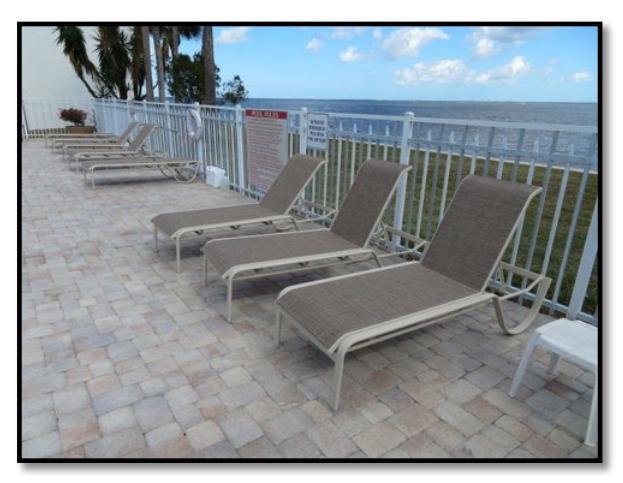
Figure 1 – Pool Furniture

The pool furniture includes lounges, tables and chairs. The pool furniture is in good condition at an age of one year. The pool furniture has a useful life from 5- to 10-years. Pelican Point should budget for replacement by 2029 and every seven years thereafter. The Association should fund interim restrapping through the operating budget as needed.
